# FACILITY CONDITION ASSESSMENT

**TROTH STREET ELEMENTARY SCHOOL**  
5565 Troth Street  
Jurupa Valley, California 91752

139069.19R000-001.354

August 28, 2019

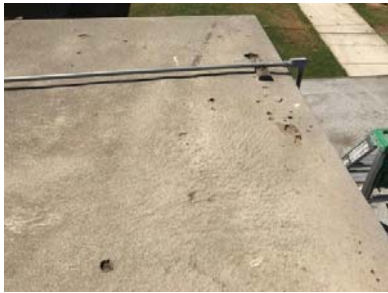
### Roof in Poor condition.

any type per man-day  
Building B (Classroom 13) Roof

The spray polyurethane roof has areas of cracks, blisters, abrasions, and other damage. These deficiencies may lead to further issues, such as moisture infiltration. - AssetCALC ID: 1362823

Uniformat Code: B3011  
Recommendation: **Repair in 2019**

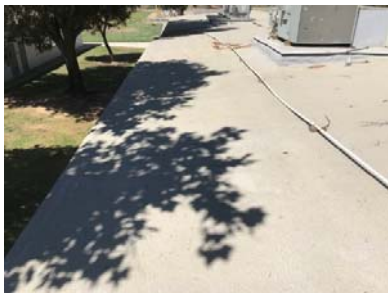
### Roof in Poor condition.

any type per man-day  
Building D (Classrooms 9-12) Roof

The spray polyurethane roof has areas of cracks, blisters, abrasions, and other damage. The POC reported active roof leaks. - AssetCALC ID: 1362926

Uniformat Code: B3011  
Recommendation: **Repair in 2019**

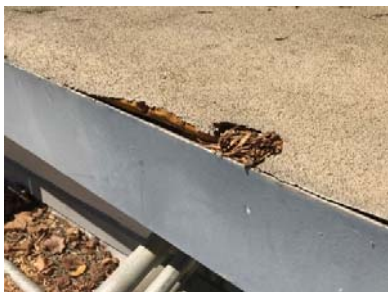
### Roof in Poor condition.

any type per man-day  
Building F (Classrooms 5-8) Roof

The spray polyurethane roof has areas of cracks, blisters, abrasions, and other damage. These deficiencies may lead to further issues, such as moisture infiltration. - AssetCALC ID: 1362946

Uniformat Code: B3011  
Recommendation: **Repair in 2019**

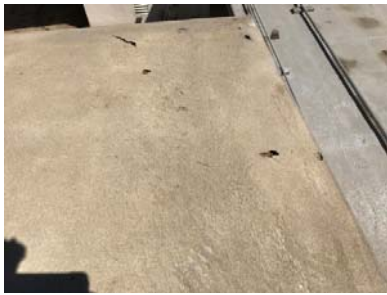
**Roof in Poor condition.**Priority Score: **90.0**

any type per man-day  
Building C (Classrooms 14-17) Roof

The spray polyurethane roof has areas of cracks, blisters, abrasions, and other damage. These deficiencies may lead to further issues, such as moisture infiltration. - AssetCALC ID: 1362795

Uniformat Code: B3011  
Recommendation: **Repair in 2019**

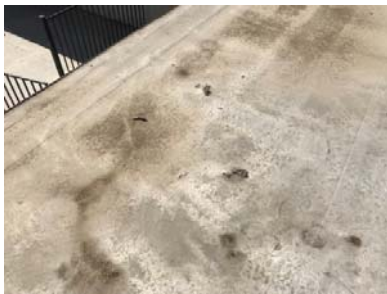
**Roof in Poor condition.**Priority Score: **90.0**

any type per man-day  
Site Canopy

Canopy roof adjacent to classroom 18 has areas of damage. - AssetCALC ID: 1362772

Uniformat Code: B3011  
Recommendation: **Repair in 2019**

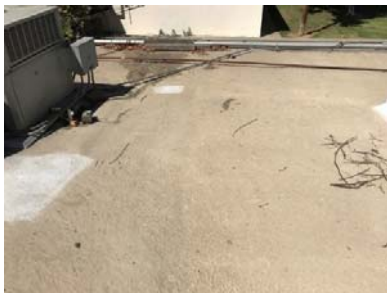
**Roof in Poor condition.**Priority Score: **90.0**

any type per man-day  
Building A (Borrego Clinic) Roof

The spray polyurethane roof has areas of cracks, blisters, abrasions, and other damage. These deficiencies may lead to further issues, such as moisture infiltration. - AssetCALC ID: 1362836

Uniformat Code: B3011  
Recommendation: **Repair in 2019**

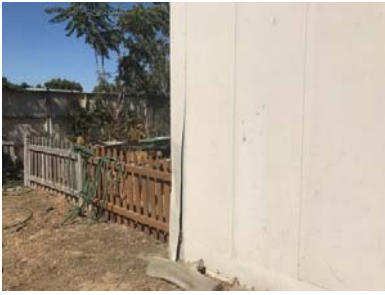
**Exterior Wall in Poor condition.**Priority Score: **90.0**Steel, 1-2 Stories  
Portables P19-P22 Room 22Plan Type:  
Performance/IntegrityUniformat Code: B2011  
Recommendation: **Repair in 2019**

Wall on back of classroom 22 shows signs of damage. - AssetCALC ID: 1362705

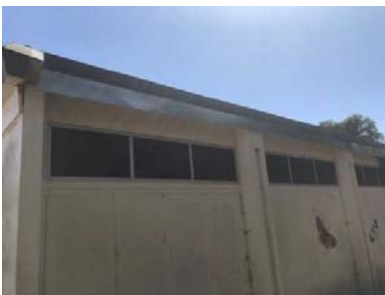
**Gutter and Downspout in Poor condition.**Priority Score: **90.0**any type per man-day  
Portables P19-P22 RoofPlan Type:  
Performance/IntegrityUniformat Code: B3011  
Recommendation: **Repair in 2019**

The gutter section at the rear of classroom 19 is missing. The adjacent downspouts are missing and damaged. A budgetary cost for repair/replacement is included. - AssetCALC ID: 1362687

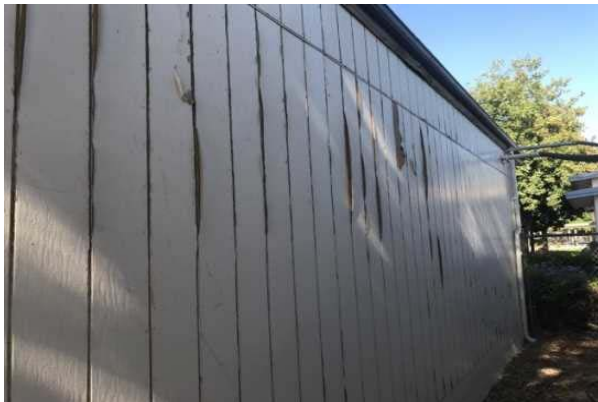
#17	DETERIORATED WOOD SIDING
-----	--------------------------

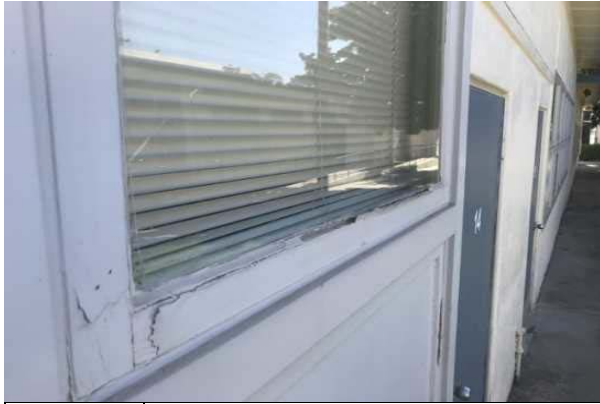
#19	DETERIORATED WOOD WINDOW FRAME AND GLAZING PUTTY
-----	--

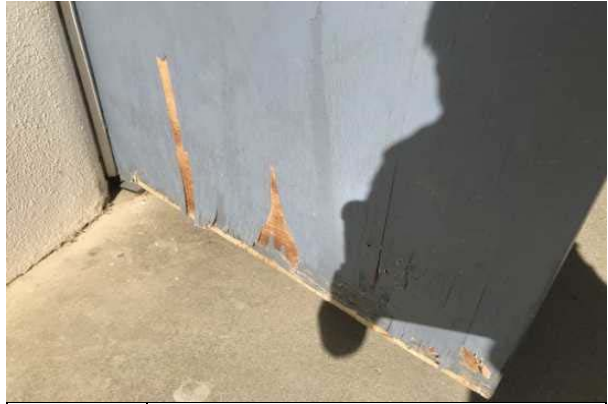
#20	DETERIORATED WOOD DOOR
-----	------------------------

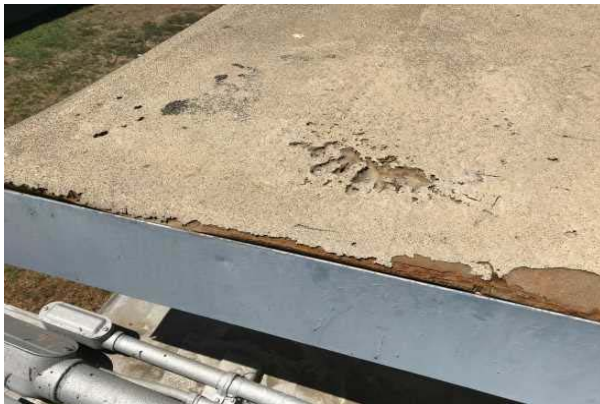
#23	DAMAGED SPRAY POLYURETHANE FOAM ROOFING
-----	---

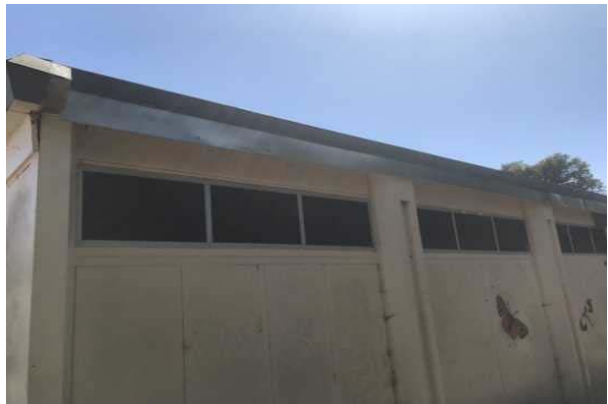
#24	DAMAGED GUTTER AND DOWNSPOUT
-----	------------------------------

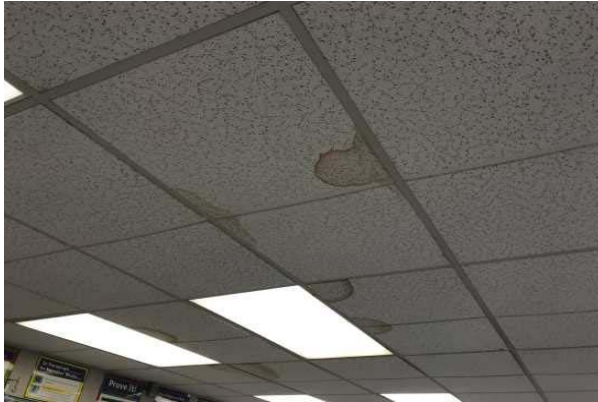
#25	STAINED CEILING TILES FROM ACTIVE ROOF LEAKS
-----	--

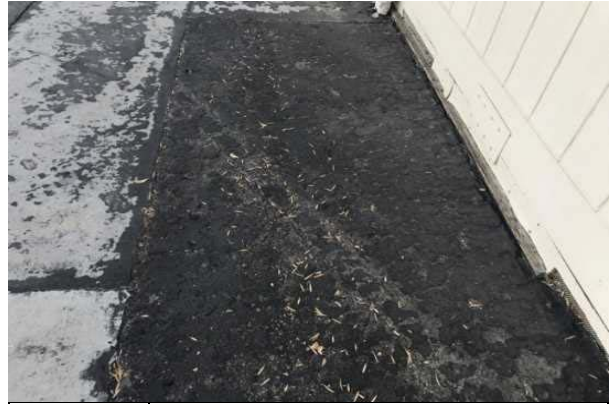
#38	WEATHERED ASPHALT WALKWAY
-----	---------------------------

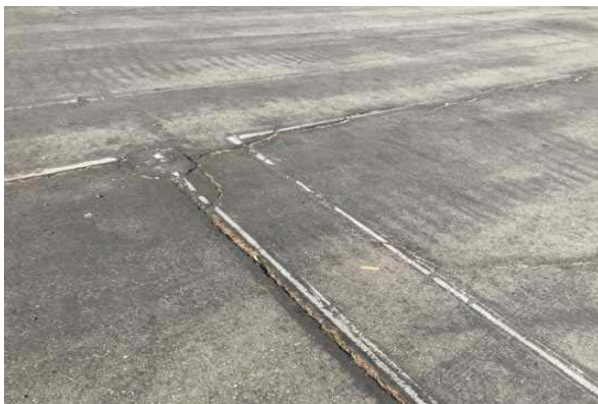
#41	DETERIORATED ASPHALT SPORTS COURT
-----	-----------------------------------

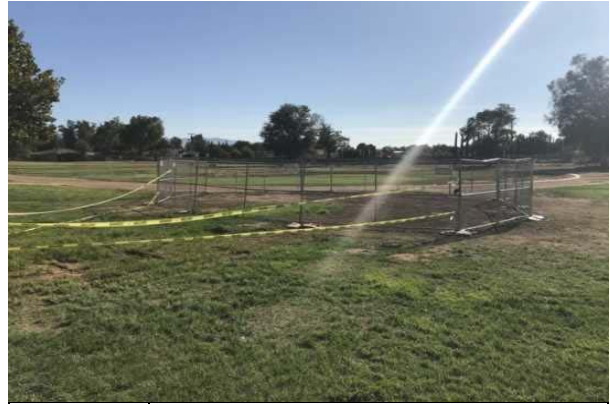
Stormwater drainage throughout the site is reported to be inadequate, which has caused ponding water, landscaping erosion, and other significant issues. There is limited stormwater infrastructure, and drainage is primarily provided by surface runoff. A professional consultant must be retained to analyze the existing condition, provide recommendations and, if necessary, estimate the scope and cost of any required repairs. The cost of this study is included in the cost tables. A budgetary cost allowance to repair and remediate the stormwater drainage issue is also included.

#44	AREA OF STORMWATER DRAINAGE DAMAGE
-----	------------------------------------

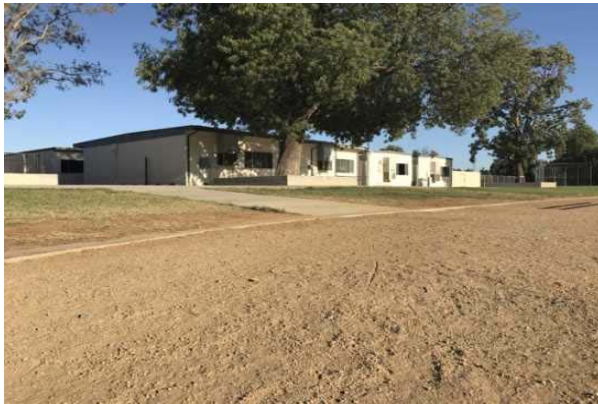
#45	SLOPE OF WALKWAY/RAMP TO TRACK NOT ADA ACCESSIBLE
-----	---
