# FACILITY CONDITION ASSESSMENT

139069.19R000-004.354

October 29, 2019

**GLEN AVON ELEMENTARY SCHOOL**  
4352 Pyrite Avenue  
Jurupa Valley, California 92509

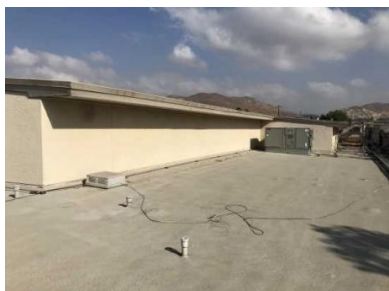
### Roof in Poor condition.

Modified Bituminous  
MPR Building MPR Roof

Roof in poor condition, big holes in the roof foam and cracks all over the roof membrane. - AssetCALC ID: 1417555

Uniformat Code: B3011  
Recommendation: **Replace in 2021**

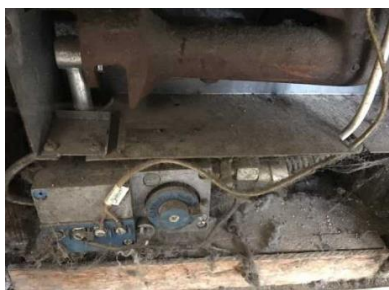
### Furnace in Failed condition.

26 - 40 MBH  
MPR Building MPR Building-Kitchen

Not working - AssetCALC ID: 1417593

Uniformat Code: D3051  
Recommendation: **Replace in 2019**

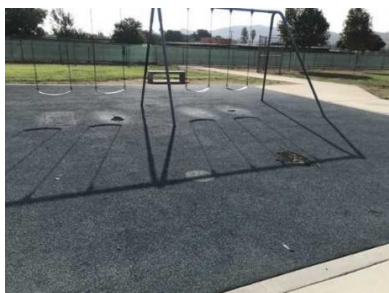
### Play Surfaces & Sports Courts in Poor condition.

Poured-in-place Rubber  
Site Playground

Playground poured-in-place Rubber is in a poor condition with multiple holes and cracks in the ground. - AssetCALC ID: 1417600

Uniformat Code: G2047  
Recommendation: **Replace in 2021**

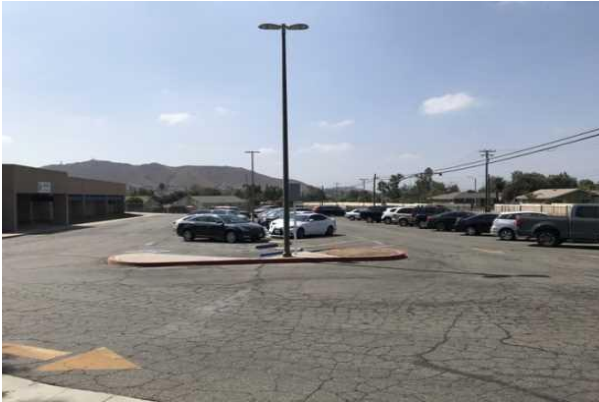
#7	FRONT PARKING LOTS
----	--------------------

In general, the sites have been well maintained. The majority of the sites contain moderate landscaping, which are served by in-ground irrigation systems. The front asphalt paved parking areas and drive aisles requires sealing and striping. The rear concrete parking areas and drive aisles are well maintained and in a fair condition. Both parking lot are shared with the county building.
