FACILITY CONDITION ASSESSMENT

October 30, 2019

PEDLEY ELEMENTARY SCHOOL
5871 Hudson Street
Jurupa Valley, California 92509

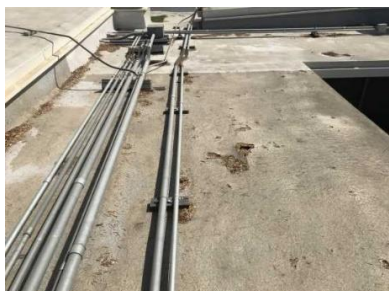
Roof in Poor condition.

Sprayed Polyurethane Foam Roofing (Replace with Modified Bitumen)
Office Building Roof

Uniformat Code: B3011
Recommendation: **Replace in 2020**
