FACILITY CONDITION ASSESSMENT

October 22, 2019

PERALTA ELEMENTARY SCHOOL

6450 Peralta Place
Jurupa Valley, California 92509

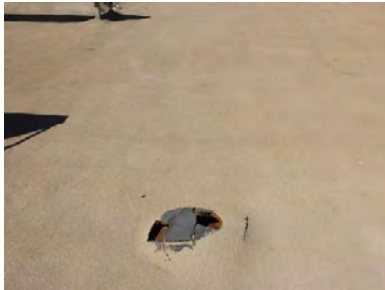
Single-Ply EPDM Membrane
Building G Roof

Roof in Poor condition.

The roof is beginning to fail and develop voids and pockets throughout. Replacement is recommended. -
AssetCALC ID: 1434711

Uniformat Code: B3011
Recommendation: **Replace in 2019**

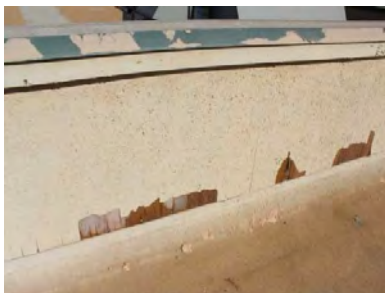
Single-Ply EPDM Membrane
Building E Roof

Roof in Poor condition.

The polyurethane foam covering is beginning to deteriorate and chip exposing the roof to further damage. -
AssetCALC ID: 1429964

Uniformat Code: B3011
Recommendation: **Replace in 2019**

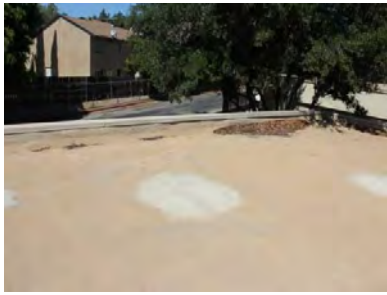
Single-Ply EPDM Membrane
Building D Roof

Roof in Poor condition.

The roof is beginning to fail and develop voids and pockets throughout. Replacement is recommended. -
AssetCALC ID: 1434904

Uniformat Code: B3011
Recommendation: **Replace in 2019**

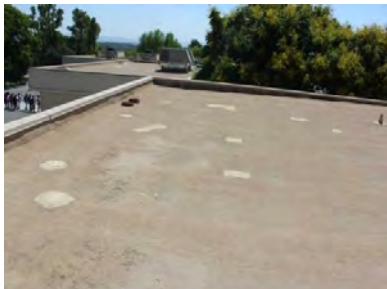
Single-Ply EPDM Membrane
Building B Roof

Roof in Poor condition.

The roof is beginning to fail and develop voids and pockets throughout. Replacement is recommended. -
AssetCALC ID: 1435623

Uniformat Code: B3011
Recommendation: **Replace in 2019**

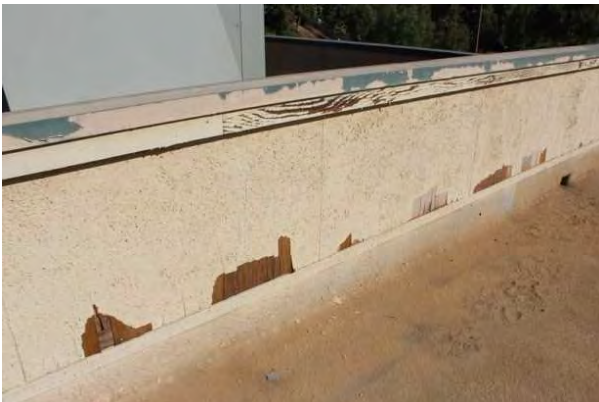
#11	ROOF DETERIORATION
-----	--------------------
