FACILITY CONDITION ASSESSMENT

November 18, 2019

RUSTIC LANE ELEMENTARY SCHOOL

6420 Rustic Lane
Jurupa Valley, California 92509

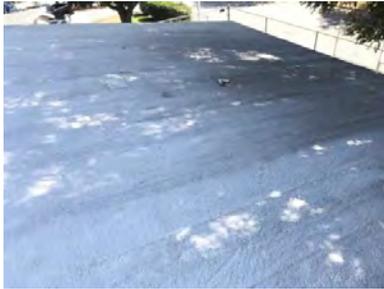
Built-Up
Building F (Office/MPR) Main Buildings Roof

Roof in Poor condition.

Recurring leaks reported throughout. - AssetCALC ID: 1492200

Uniformat Code: B3011
Recommendation: **Replace in 2021**

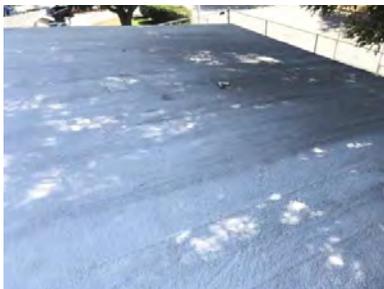
Built-Up
Building G (Kindergarten) Main Buildings Roof

Roof in Poor condition.

Recurring leaks reported throughout. - AssetCALC ID: 1492222

Uniformat Code: B3011
Recommendation: **Replace in 2021**

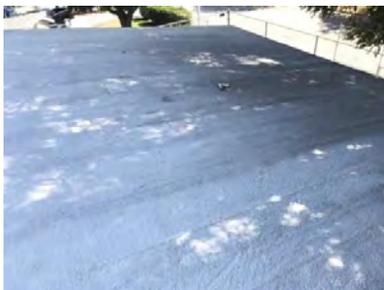
Built-Up
Building B (Classrooms) Main Buildings Roof

Roof in Poor condition.

Recurring leaks reported throughout. - AssetCALC ID: 1492112

Uniformat Code: B3011
Recommendation: **Replace in 2021**

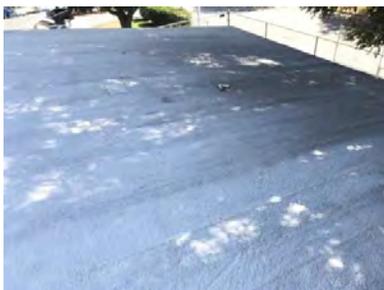
Built-Up
Building D (Classrooms) Main Buildings Roof

Roof in Poor condition.

Recurring leaks reported throughout. - AssetCALC ID: 1492156

Uniformat Code: B3011
Recommendation: **Replace in 2021**

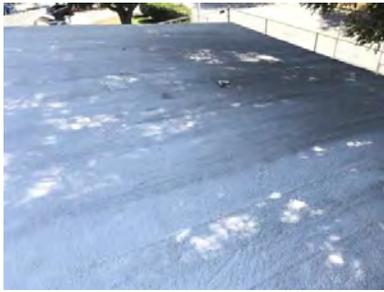
Built-Up
Building A (Classrooms) Main Buildings Roof

Roof in Poor condition.

Recurring leaks reported throughout. - AssetCALC ID: 1492090

Uniformat Code: B3011
Recommendation: **Replace in 2021**

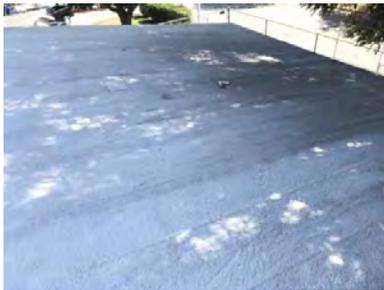
Built-Up
Building C (Classrooms) Main Buildings Roof

Roof in Poor condition.

Recurring leaks reported throughout. - AssetCALC ID: 1492134

Uniformat Code: B3011
Recommendation: **Replace in 2021**

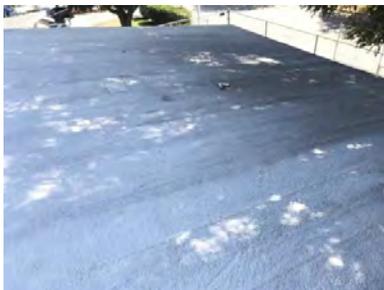
Built-Up
Building E (Classrooms) Main Buildings Roof

Roof in Poor condition.

Recurring leaks reported throughout. - AssetCALC ID: 1492178

Uniformat Code: B3011
Recommendation: **Replace in 2021**

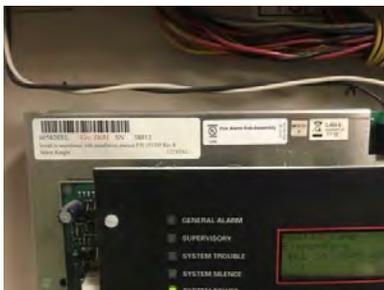
Basic/Zoned
Building F (Office/MPR) Electrical room

Fire Alarm Control Panel in Poor condition.

Panel makes a tapping sound despite no moving parts - AssetCALC ID: 1436942

Uniformat Code: D5037
Recommendation: **Replace in 2021**

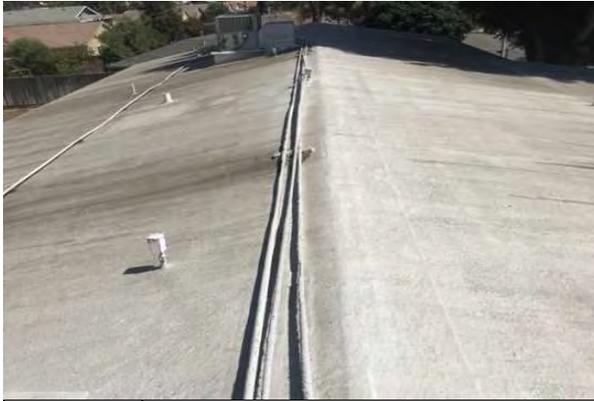
#25	PRIMARY ROOF OVERVIEW
-----	-----------------------

The roofs of the main buildings are in poor condition. Roof leaks are reported in four to five locations. A professional engineer must be retained to analyze the existing condition, provide recommendations and, if necessary, estimate the scope and cost of any required repairs. The cost of this study is included in the cost tables. A budgetary cost allowance to replace the roofing is also included.

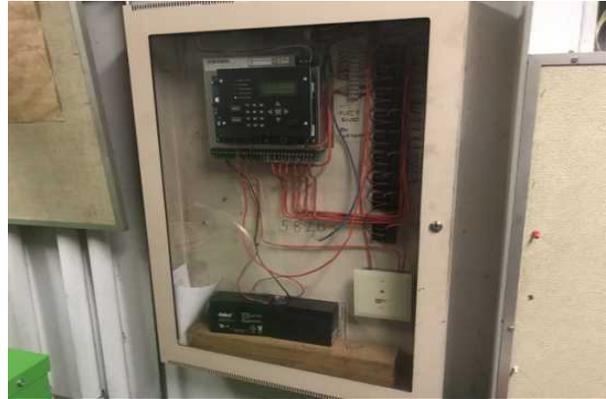
#38	FIRE ALARM CONTROL PANEL
-----	--------------------------

The electrical infrastructure was upgraded in 2016, replacing or rebuilding transformers and other electrical assets. Switchboards are original and antiquated. The plumbing systems are largely original with fixtures replaced in the 1998 refurbishment. Sewage is reported to back up regularly in Buildings A and F. Hot water is provided to the kitchen by a gas water heater and in select locations by small electric water heaters. Sprinkler coverage is limited to building F. Expansion to the other permanent buildings via retrofit is recommended and respective cost is included. The fire alarm control panel exhibits a tapping sound and replacement is recommended.

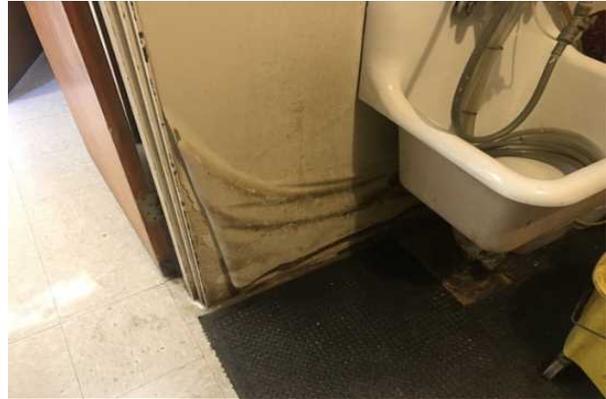
#44	DAMAGED VINYL WALLS
-----	---------------------

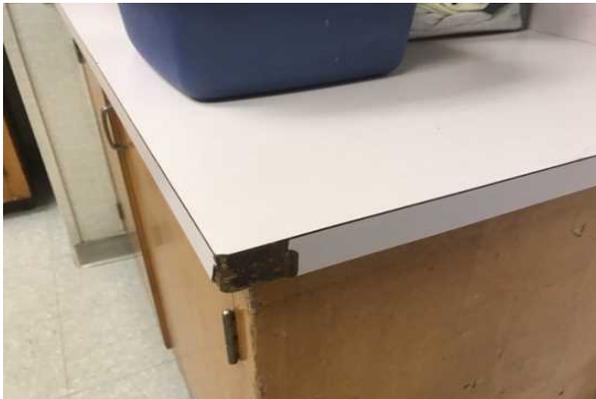
#45	DELAMINATING COUNTERTOPS
-----	--------------------------

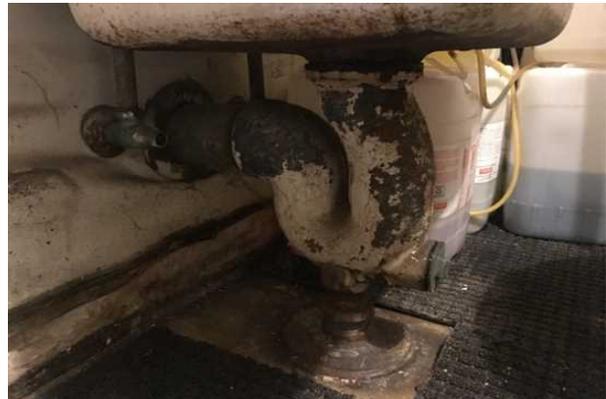
Sewage is reported to back up regularly in Buildings A and F. A professional engineer must be retained to analyze the existing condition, provide recommendations and, if necessary, estimate the scope and cost of any required repairs. The cost of this study is included in the cost tables. Due to the ambiguity of the required repair scope at the time of this assessment, the cost for any possible subsequent repairs is not included.

#46	SEWAGE PIPING, PRONE TO BACK-UPS
-----	----------------------------------

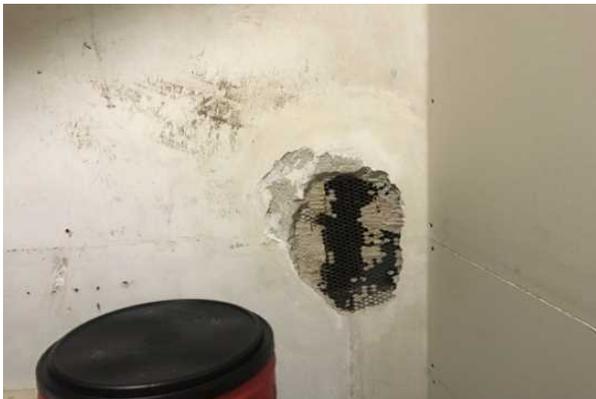
#47	DAMAGED UTILITY WALLS
-----	-----------------------

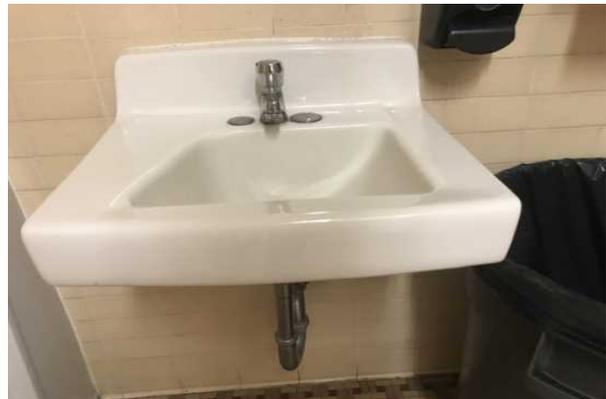
#48	LAVATORIES LACK PIPE WRAPPING
-----	-------------------------------
