# FACILITY CONDITION ASSESSMENT

**STONE AVENUE ELEMENTARY SCHOOL**  
5111 Stone Avenue  
Jurupa Valley, California 92509

139069.19R000-014.354

November 20, 2019

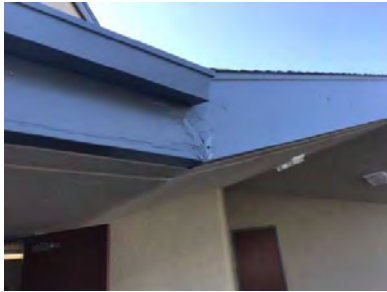
**Soffit in Poor condition.**

Wood  
Building A (Main) Building Exterior

Wood at roofing trim is rotting beneath paint. Appears to be engineered beams. - AssetCALC ID: 1443254

Uniformat Code: B2016  
Recommendation: **Replace in 2020**

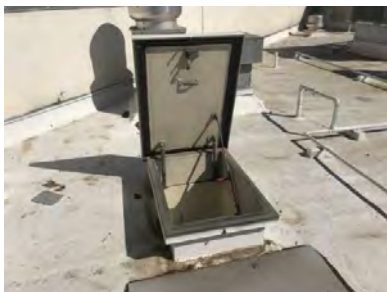
**Roof Hatch in Poor condition.**

Metal  
Building A (Main) Roof

Ladder not secured properly - AssetCALC ID: 1443159

Uniformat Code: B3022  
Recommendation: **Replace in 2020**

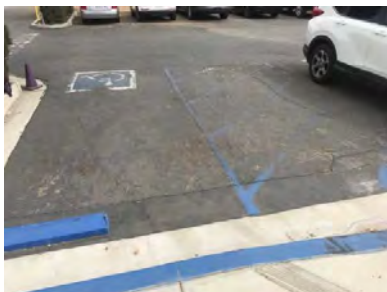
**Parking Lots in Poor condition.**

Asphalt Pavement  
Site Site

Sealcoat and striping have worn away. - AssetCALC ID: 1443215

Uniformat Code: G2022  
Recommendation: **Seal & Stripe in 2020**

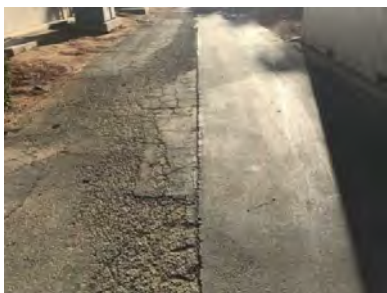
**Parking Lots in Poor condition.**

Asphalt Pavement  
Site Site

Extensive alligator cracking, potholes, and totally worn away pavement observed. - AssetCALC ID: 1443126

Uniformat Code: G2022  
Recommendation: **Mill & Overlay in 2020**

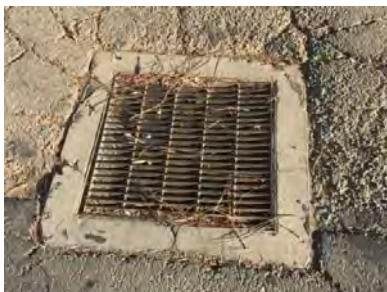
**Plumbing System in Poor condition.**

Rainwater Drainage, Low Density  
Site

Periodic site erosion problems. - AssetCALC ID: 1443203

Uniformat Code: D2049  
Recommendation: **Replace in 2021**

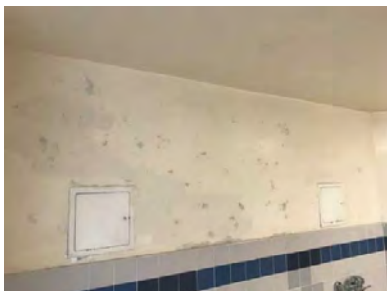
**Interior Wall Finish in Poor condition.**

any surface  
Building A (Main) Throughout

Uniformat Code: C3012  
Recommendation: **Prep & Paint in 2021**

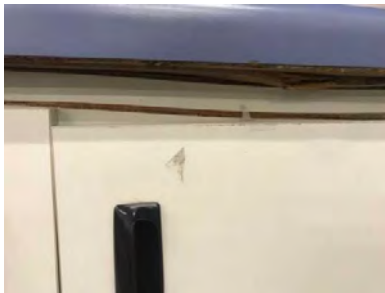
**Kitchen Counter in Poor condition.**

Plastic Laminate, Postformed  
Building A (Main) Throughout

Delamination and warping common in all counters except 2-story classrooms. - AssetCALC ID: 1443177

Uniformat Code: E2012  
Recommendation: **Replace in 2019**

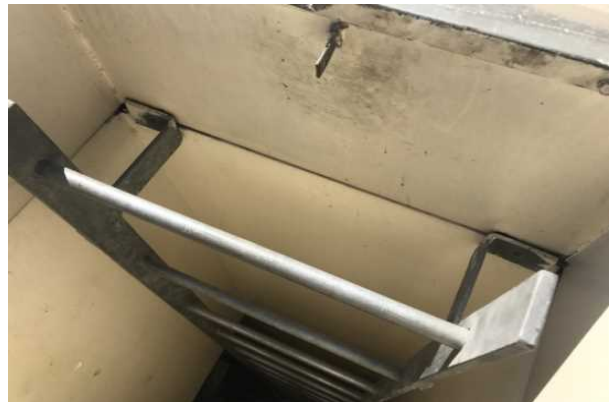
#42	ROOF HATCH ISSUE
-----	------------------

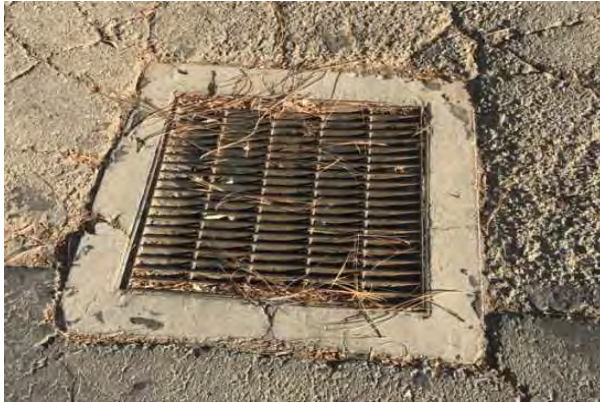
#43	INSUFFICIENT SITE DRAINAGE
-----	----------------------------

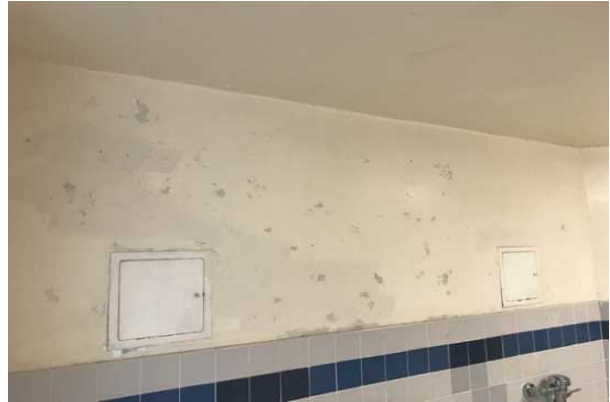
#44	CHIPPED PAINT IN RESTROOMS
-----	----------------------------

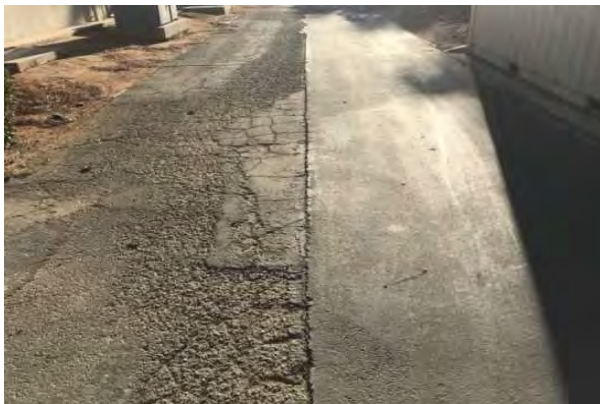
#45	DAMAGED ASPHALT PAVEMENT
-----	--------------------------

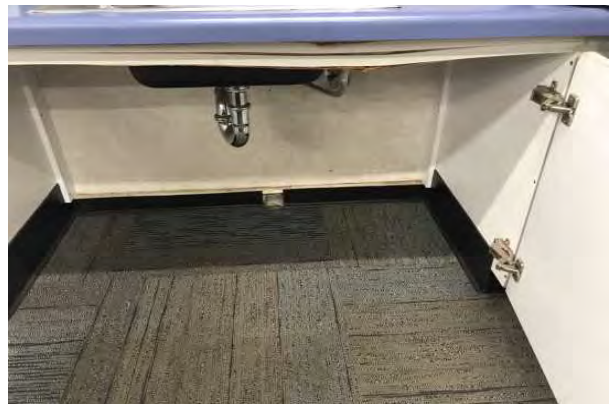
#46	DAMAGED COUNTERTOPS
-----	---------------------

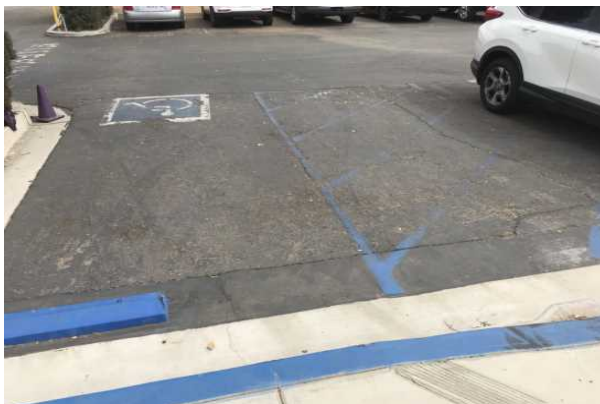
#47	WORN STRIPING, DEGRADED SEALCOAT
-----	----------------------------------

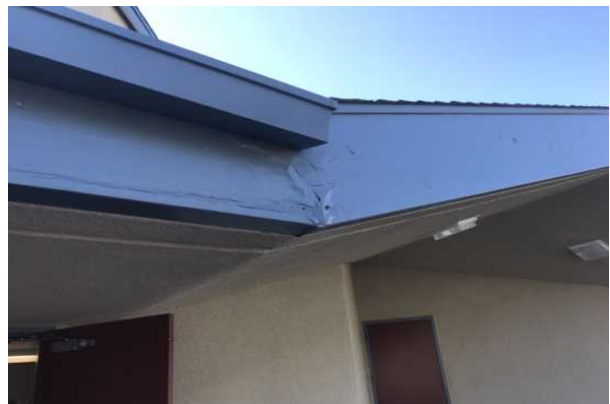
#48	ROOF TRIM ISSUE
-----	-----------------
