FACILITY CONDITION ASSESSMENT

VAN BUREN ELEMENTARY SCHOOL
9501 Jurupa Road
Jurupa Valley, California 92509

October 4, 2019

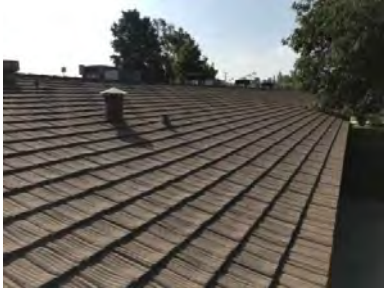
any type per man-day
Building E Roof

Roof in Poor condition.

Roof leak was reported at room E2. Repair is required. - AssetCALC ID: 1420539

Uniformat Code: B3011
Recommendation: **Repair in 2019**

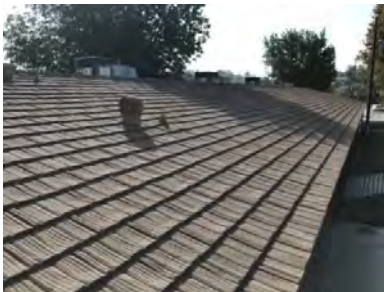
any type per man-day
Building D Roof

Roof in Poor condition.

Roof leaks were reported at rooms D3 and D4. Repair is required. - AssetCALC ID: 1420501

Uniformat Code: B3011
Recommendation: **Repair in 2019**

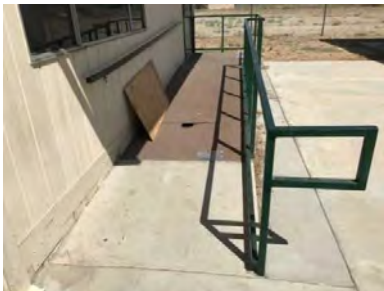
Wood
Portable P-11 Main entrance

Exterior Stairs in Poor condition.

Section of the floor plywood is broken; the repair is required. - AssetCALC ID: 1419386

Uniformat Code: B1015
Recommendation: **Replace in 2020**

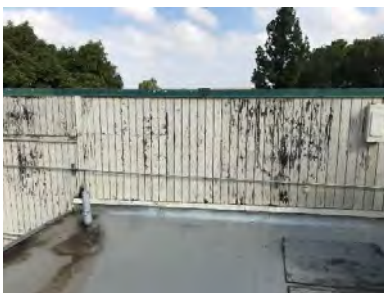
Wood Clapboard Siding, 1-2 Stories
Building M Building Exterior- flat roof area

Exterior Wall in Poor condition.

The wood is damaged and deteriorated. - AssetCALC ID: 1416327

Uniformat Code: B2011
Recommendation: **Replace in 2020**

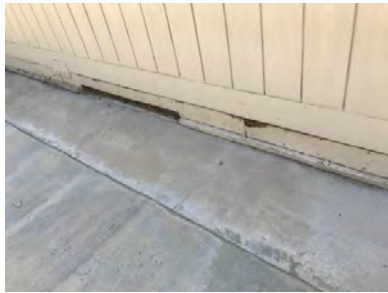
Textured Plywood (T1-11)
Portable P-07 Building Exterior

Exterior Wall in Poor condition.

Isolated areas of deteriorated wood panels. - AssetCALC ID: 1416337

Uniformat Code: B2011
Recommendation: **Replace in 2021**

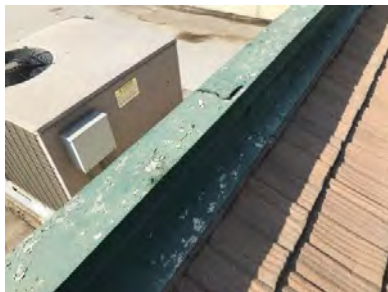
any Painted Surface, 1-2 Stories
Building M Roof

Exterior Wall in Poor condition.

The roof cooping needs new paint. - AssetCALC ID: 1416389

Uniformat Code: B2011
Recommendation: **Prep and Paint in 2020**

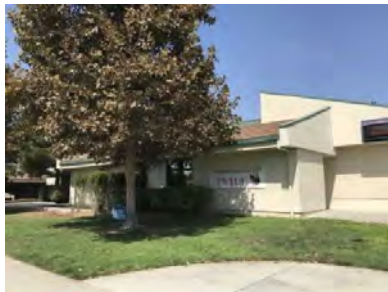
Wood
Building M Building Exterior

Window in Poor condition.

Windows leaks were reported at the MPR atrium. Repair is required. - AssetCALC ID: 1420477

Uniformat Code: B2021
Recommendation: **Repair in 2019**

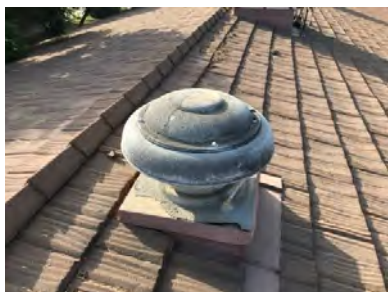
Roof or Wall Mounted, 50 to 500 CFM
Building B Building B

Exhaust Fan in Poor condition.

The unit is rusty and not fully operational. - AssetCALC ID: 1416452

Uniformat Code: D3042
Recommendation: **Replace in 2021**

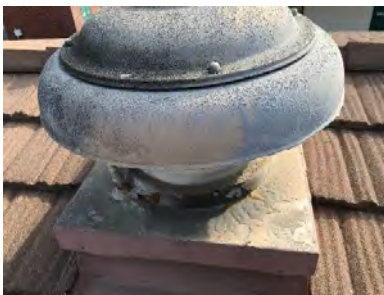
Roof or Wall Mounted, 50 to 500 CFM
Building C Roof

Exhaust Fan in Poor condition.

The unit is rusty and not fully operational. - AssetCALC ID: 1416485

Uniformat Code: D3042
Recommendation: **Replace in 2021**

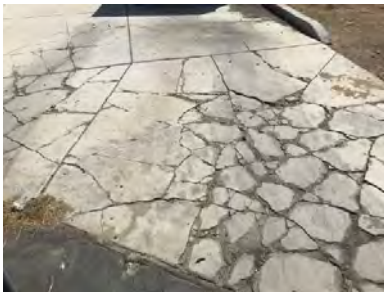
Concrete Pad
Site Site- trash enclosure area

Dumpster Accessories in Poor condition.

The concrete is broken and uneven. - AssetCALC ID: 1416324

Uniformat Code: G2049
Recommendation: **Replace in 2020**

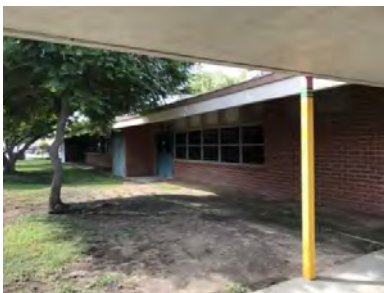
Site Landscaping

Irrigation System in Poor condition.

isolated areas of water coverage and lack of irrigation system performance for the landscaping. - AssetCALC ID: 1420394

Uniformat Code: G2057
Recommendation: **Replace/Install in 2021**

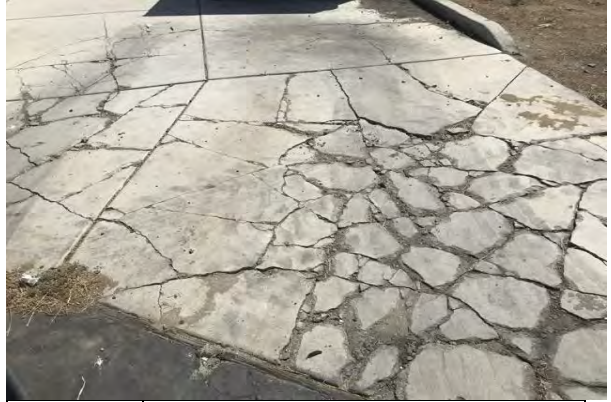
| #20 | DAMAGED CONCRETE FLOORING AT TRASH ENCLOSURE |

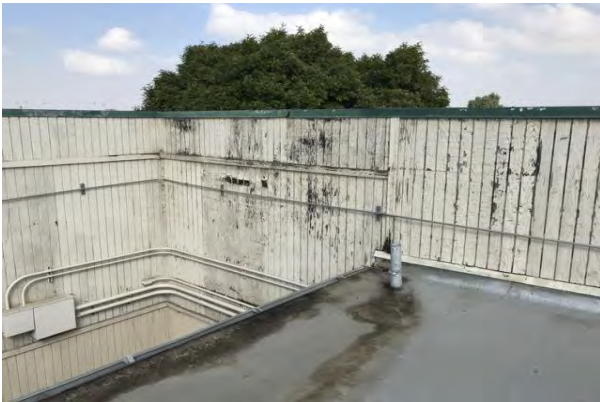
| #21 | DAMAGED EXTERIOR WALL AT BUILDING M |
