FACILITY CONDITION ASSESSMENT

January 14, 2020

WEST RIVERSIDE ELEMENTARY SCHOOL
3972 Riverview Drive
Jurupa Valley, California 92509

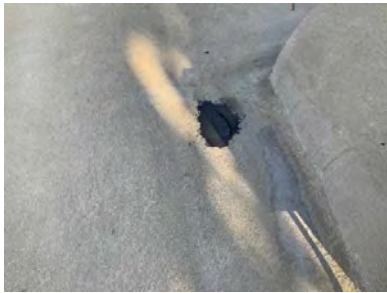
Modified Bituminous
Building C Classrooms Roof

Roof in Poor condition.

The roof system has failed and needs to be addressed. - AssetCALC ID: 1460300

Uniformat Code: B3011
Recommendation: **Replace in 2021**

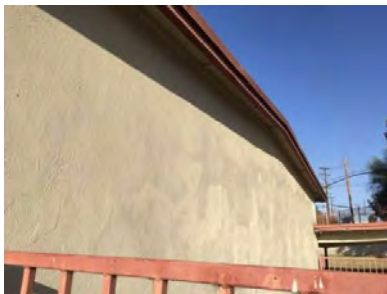
any Painted Surface, 1-2 Stories
Building A Classrooms Building Exterior

Exterior Wall in Fair condition.

Uniformat Code: B2011
Recommendation: **Prep and Paint in 2022**

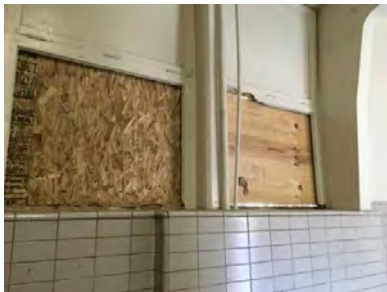
24 SF
Building G Classrooms Building Exterior Boys
Restroom

Window in Failed condition.

Windows are missing, replace. - AssetCALC ID: 1492808

Uniformat Code: B2021
Recommendation: **Replace in 2019**

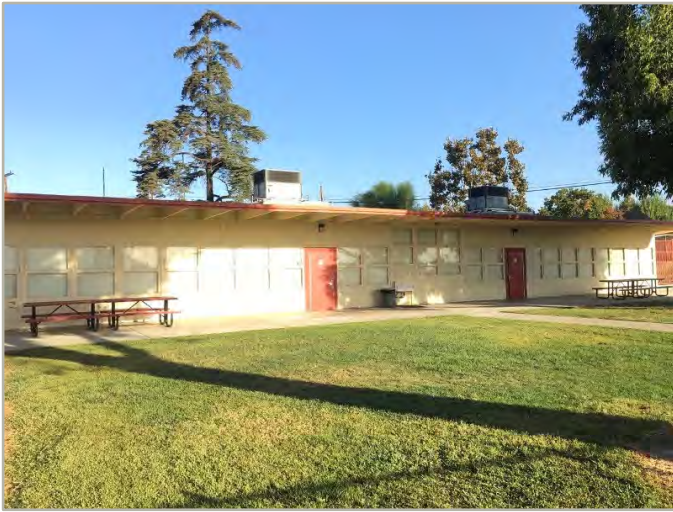
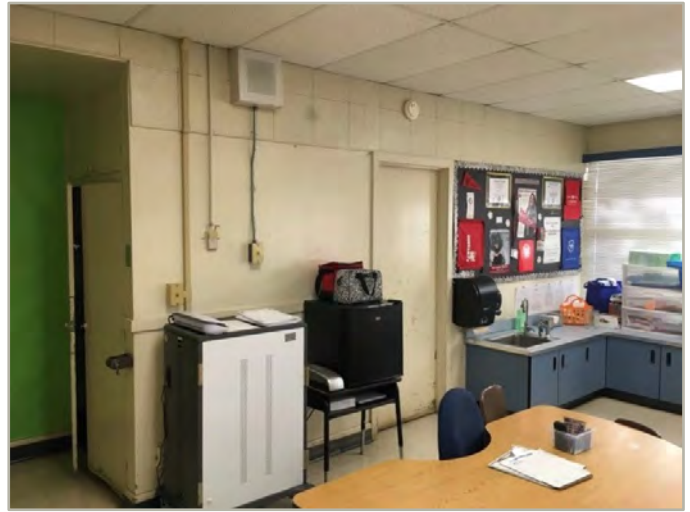
2. Building A Classrooms

Building A: Systems Summary		
HVAC	Individual roof mounted package	Fair
Fire Suppression	No sprinkler system	Missing
Electrical	Source and Distribution: Panel with copper wiring, fed from on-site switchboard with copper wiring Interior Lighting: T-8, LED Emergency: None	Fair
Fire Alarm	Alarm panel, smoke detectors, alarms, strobes, pull stations, back-up emergency lights, and exit signs	Fair
Equipment/Special	None	--
Accessibility	Potential minor/moderate issues have been identified at this property and a detailed accessibility study is recommended.	
Key Issues and Findings	Older single glazed wood windows, building lacks fire suppression, aged electrical infrastructure.

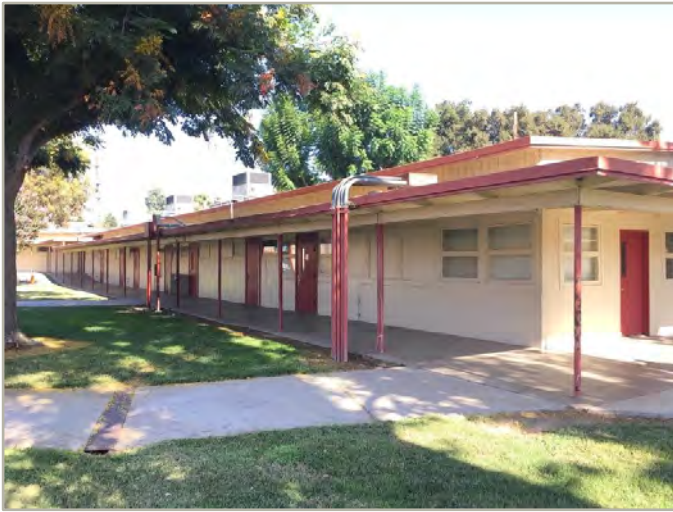
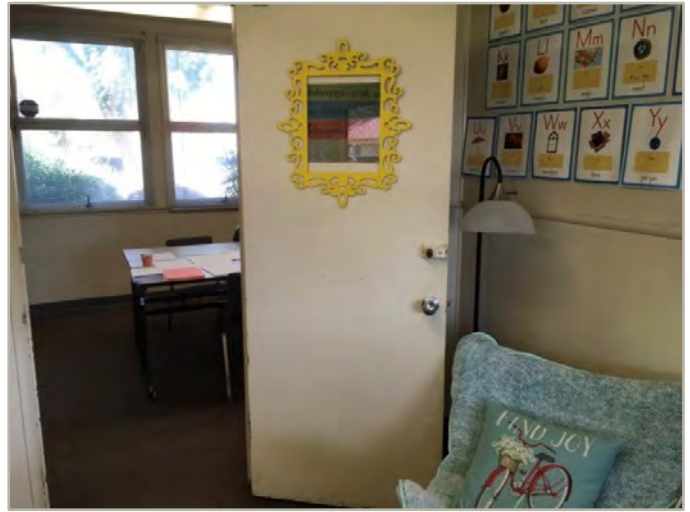
5. Building C Classrooms

Building C: Systems Summary		
HVAC	Individual roof mounted package units.	Fair
Fire Suppression	No sprinkler system	Missing
Electrical	Source and Distribution: Main switchboard with copper wiring fed from site mounted equipment with copper wiring Interior Lighting: T-8, LED Emergency: None	Fair
Fire Alarm	Smoke detectors, alarms, strobes, pull stations, back-up emergency lights, and exit signs	Fair
Equipment/Special	None	--
Accessibility	Potential minor/moderate issues have been identified at this property and a detailed accessibility study is recommended.	
Key Issues and Findings	Older single glazed wood windows, building lacks fire suppression, aged electrical infrastructure. Exterior drinking fountain and the roof system are in poor condition.

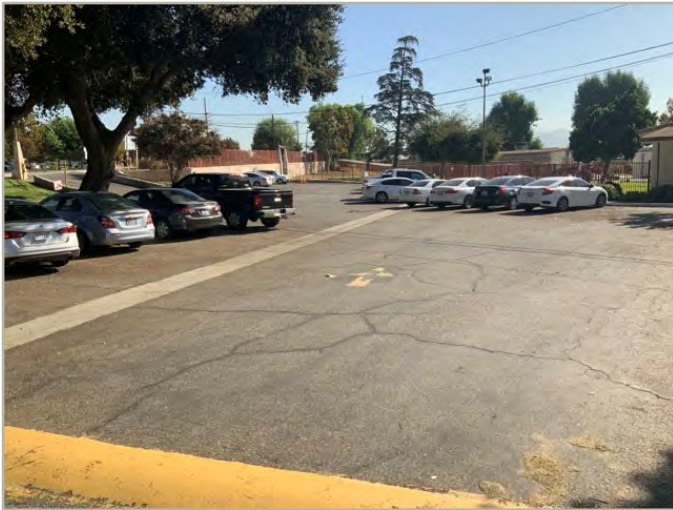
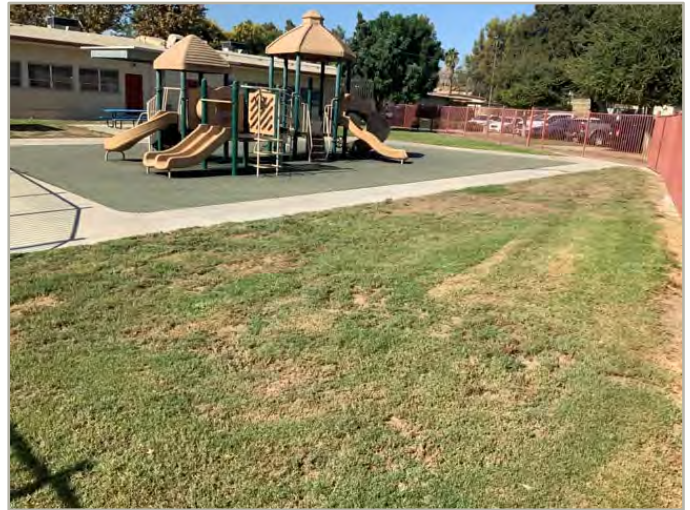
12. Site Summary

Key Issues and Findings	Heavy asphalt wear, severe alligator cracking and potholes in the front parking lot and Cafeteria lot. Some sidewalk trip hazards, inadequate site drainage. Some irrigation systems leaks. Inadequate site lighting.

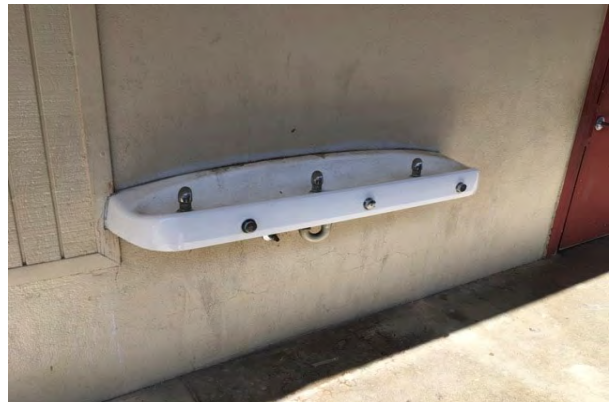
#18	DRINKING FOUNTAIN, OUTSIDE/SITE STYLE, REPLACE
-----	--
