# FACILITY CONDITION ASSESSMENT

November 26, 2019

## JURUPA MIDDLE SCHOOL

8700 Galena Street  
Jurupa Valley, CA 92509

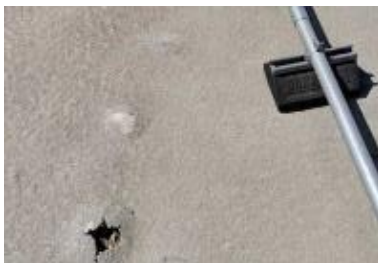
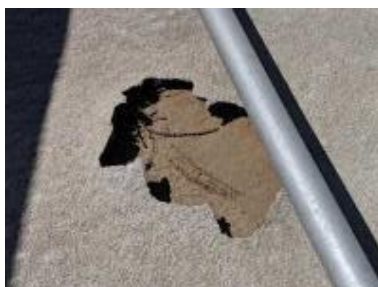
**Roof in Poor condition.**

Built-Up Roof – All Permanent Buildings A, F, 100, 200, 300 & Library

Roof has holes & moisture damage. - AssetCALC ID: 1521146-51

Uniformat Code: B3011  
 Recommendation: **Replace in 2019**

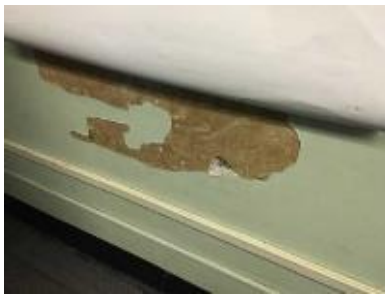
**Interior Wall Finish in Poor condition.**

Gypsum Board/Plaster  
Building 100 (B-C) Classrooms

Wallboard subsurface exposed - AssetCALC ID: 1465213

Uniformat Code: C3012  
Recommendation: **Repair in 2020**

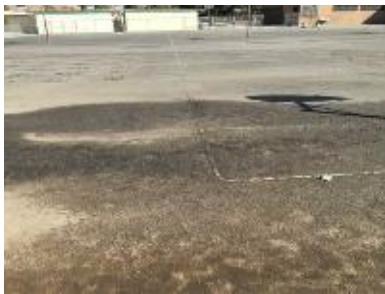
**Play Surfaces & Sports Courts in Poor condition.**

Asphalt  
Site Sports Courts

Asphalt Sports Court in Poor Condition - AssetCALC ID: 1578883

Uniformat Code: G2047  
Recommendation: **Mill & Overlay in 2019**
