FACILITY CONDITION ASSESSMENT

November 4, 2019

MIRA LOMA MIDDLE SCHOOL
5051 Steve Avenue
Jurupa Valley, California 92509

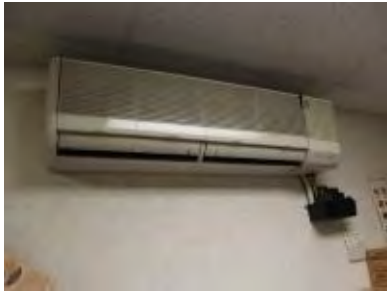
Ductless Split System in Failed condition.

Single Zone, 0.75 to 1 Ton
Building A IT room

POC indicates Ductless system not working. - AssetCALC ID: 1464940

Uniformat Code: D3032
Recommendation: **Replace in 2019**

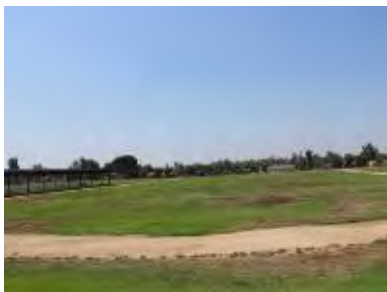
Irrigation System in Poor condition.

Site Landscaping

Uniformat Code: G2057
Recommendation: **Replace/Install in 2021**
