FACILITY CONDITION ASSESSMENT

November 14, 2019

MISSION MIDDLE SCHOOL
5961 Mustang Lane
Jurupa Valley, California 92509

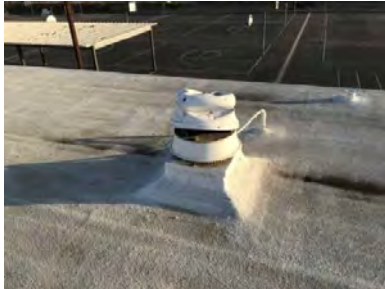
Exhaust Fan in Poor condition.

125 CFM
MPR/ Kitchen Building MPR/ Kitchen Building-
Roof

Unit is severely damaged. - AssetCALC ID: 1474529

Uniformat Code: D3042
Recommendation: **Replace in 2020**

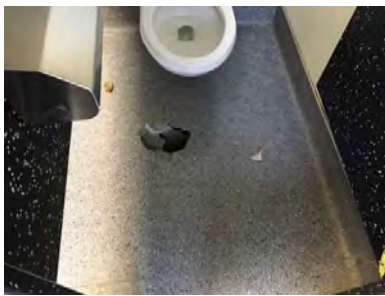
Interior Floor Finish in Poor condition.

Linoleum
Site Restrooms Site Restrooms

Will need to fix and reinforce the floor joints to prevent any future damage. - AssetCALC ID: 1474376

Uniformat Code: C3024
Recommendation: **Repair in 2019**

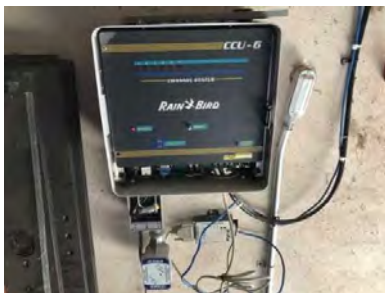
Irrigation System in Poor condition.

The client has reported that the existing irrigation system has coverage issues throughout the property. - AssetCALC ID: 1481278

Uniformat Code: G2057
Recommendation: **Replace/Install in 2021**

Uniformat Code: P000X
Recommendation: **Perform Study in 2019**

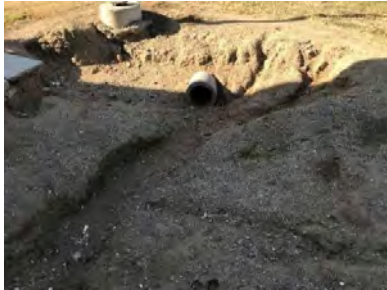
Recommended Follow-up Study: Civil, Site/Storm Drainage

Upper north side of property has erodes issue during heavy rains and west side of campus behind portable buildings. The area behind the portable buildings is starting to encroach the foundation of portable buildings #32-33. - AssetCALC ID: 1477474

Uniformat Code: P000X
Recommendation: **Evaluate/Report in 2019**

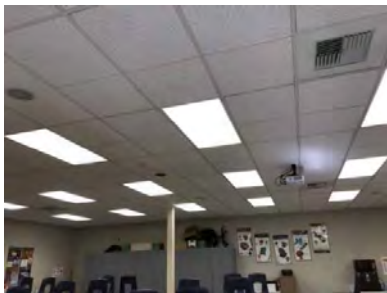
Sprinkler System

Full Retrofit, Medium Density/Complexity
Classroom Building #11-12/ Locker Rooms
Classroom Building 11-12/ Locker Rooms

There is no sprinkler system installed in this building. - AssetCALC ID: 1474288

Uniformat Code: D4019
Recommendation: **Renovate in 2024**
