FACILITY CONDITION ASSESSMENT

October 7, 2019

THE LEARNING CENTER - ADULT EDUCATION
4041 Pacific Avenue
Jurupa Valley, California 92509

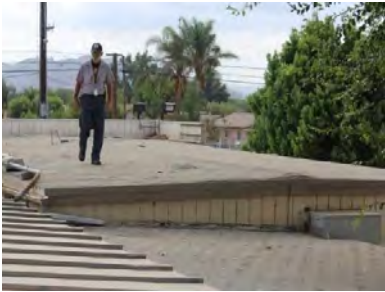
Modified Bituminous
Portable - Staff Lounge Roof

Roof in Poor condition.

Uniformat Code: B3011
Recommendation: **Replace in 2019**

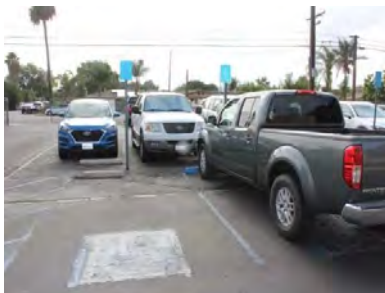
Parking Lots in Poor condition.

Most of the existing lines are worn and invisible and the asphalt is cracked and settled in many places. - AssetCALC ID: 1422513

Uniformat Code: G2022
Recommendation: **Seal and Stripe in 2020**

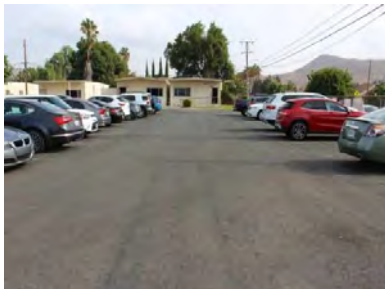
Parking Lots in Poor condition.

The asphalt pavement exhibits significant areas of failure and deterioration, such as alligator cracking, transverse cracking, extensive raveling, and localized depression. The most severely damaged areas of paving must be cut and patched in order to maintain the integrity of the overall pavement system. Complete milling and overlay of the entire lot is also recommended. - AssetCALC ID: 1422512

Uniformat Code: G2022
Recommendation: **Mill and Overlay in 2020**

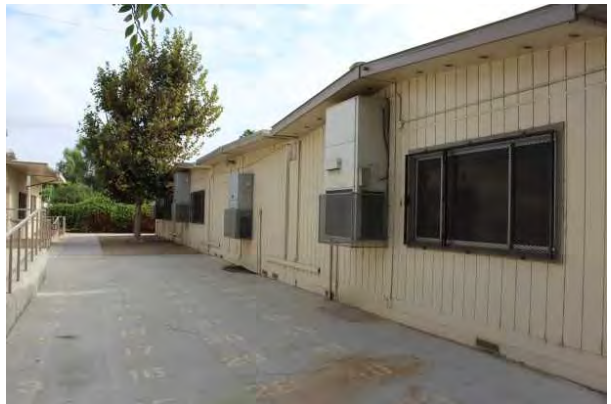
#6	PORTABLES 1 THROUGH 4
----	-----------------------

The portable classrooms are constructed of wood-framed construction with wood siding and aluminum-framed, single-paned windows. The wood siding at some of the portables is delaminated, cracked, and heavily weathered. Roofing is flat with sheet metal or modified bituminous finishes. Portable- Rooms 1 through 4 are noted to have roof leaks by the POC.

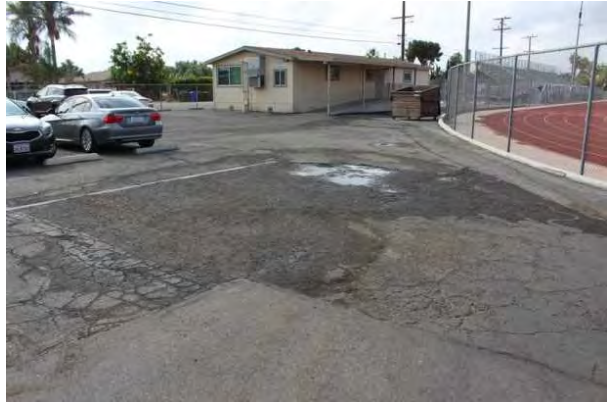
#38	PARKING LOTS, ASPHALT PAVEMENT
-----	--------------------------------

The parking lots and sidewalks have been periodically repaved and sectionally replaced as needed over the years. The parking lot has developed numerous potholes and heavy surface wear and should be milled and overlaid. The sidewalks are generally in good condition.
