# FACILITY CONDITION ASSESSMENT

MAINTENANCE, OPERATIONS AND TRANSPORTATION  
4740 Pedley Road  
Jurupa Valley, California 92509

139069.19R000-026.354

November 30, 2019

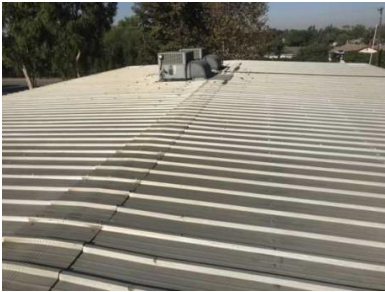
#### Roof in Poor condition.

Metal  
Building B (Print Shop) Roof

Reoccurring leaks reported. - AssetCALC ID: 1440339

Uniformat Code: B3011  
Recommendation: **Replace in 2021**

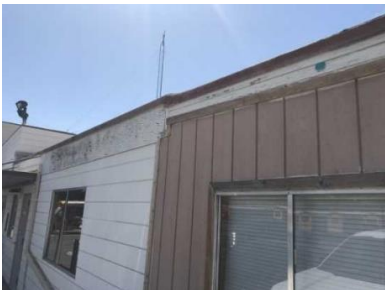
#### Soffit in Poor condition.

Wood  
Building A (Main Building) Building Exterior

Wood trim is exceedingly aged and splitting. - AssetCALC ID: 1440341

Uniformat Code: B2016  
Recommendation: **Replace in 2020**

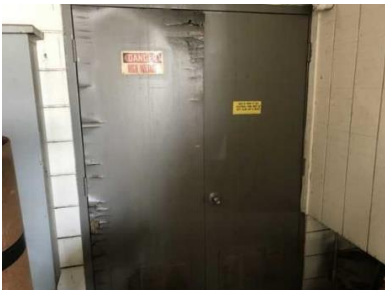
#### Exterior Door in Failed condition.

Wood Solid-Core  
Building A (Main Building) Building Exterior

Uniformat Code: B2032  
Recommendation: **Replace in 2019**

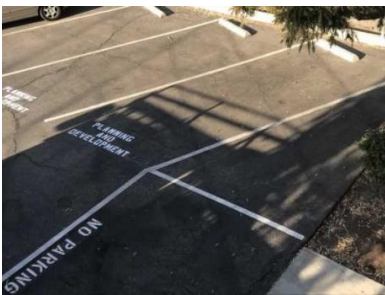
**Parking Lots in Poor condition.**

Asphalt Pavement  
Site

Sealcoat is largely worn away, particularly in bus areas. - AssetCALC ID: 1440302

Uniformat Code: G2022  
Recommendation: **Seal & Stripe in 2020**

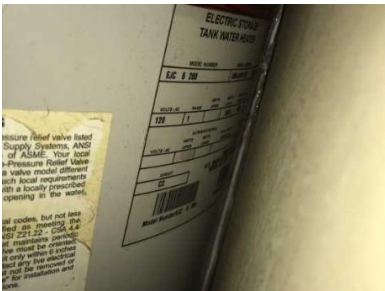
**Water Heater in Poor condition.**

6 GAL  
Building A (Main Building) Utility Closet

Water heater is covered in scale and corrosive elements. - AssetCALC ID: 1440444

Uniformat Code: D2023  
Recommendation: **Replace in 2021**

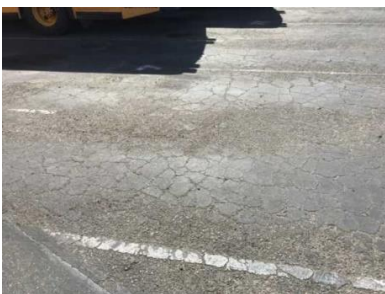
**Parking Lots in Poor condition.**

Asphalt Pavement  
Site

Heavy alligator cracking observed throughout. - AssetCALC ID: 1440434

Uniformat Code: G2022  
Recommendation: **Mill & Overlay in 2020**

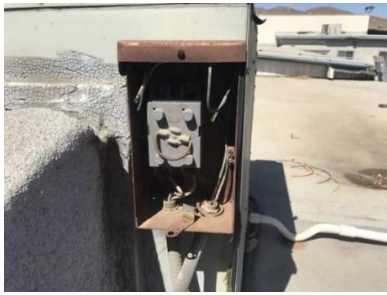
**Packaged Unit (RTU) in Poor condition.**

3.5 TON  
Building A (Main Building) Roof

Unit observed to malfunction - AssetCALC ID: 1440279

Uniformat Code: D3052  
Recommendation: **Replace in 2021**

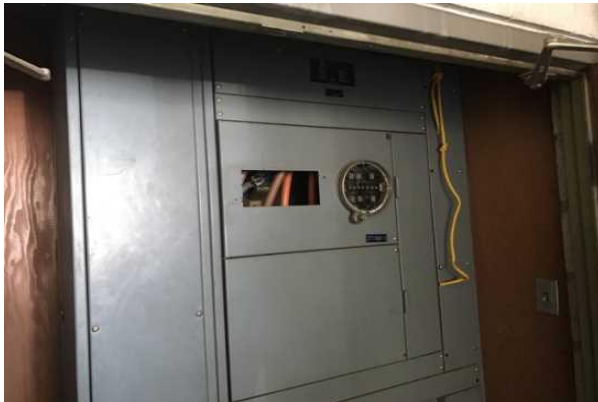
| #39 | ANTIQUATED ELECTRICAL INFRASTRUCTURE |

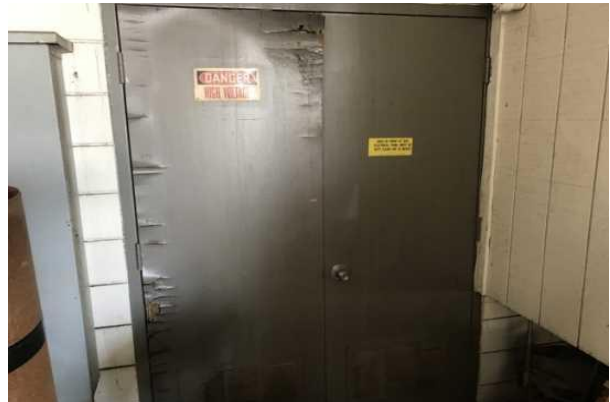
| #40 | DAMAGED DOORS TO UTILITY CLOSET |

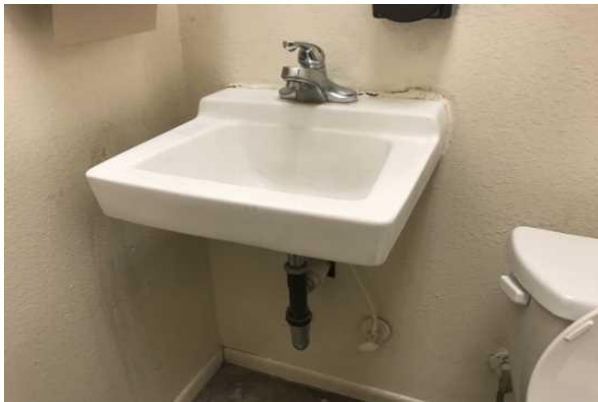
| #41 | LAVATORIES LACK PIPE WRAPS |

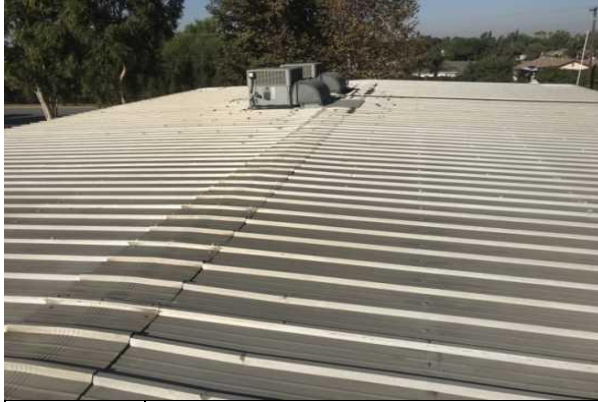
| #43 | PRINT SHOP ROOF LEAKS REPORTED |

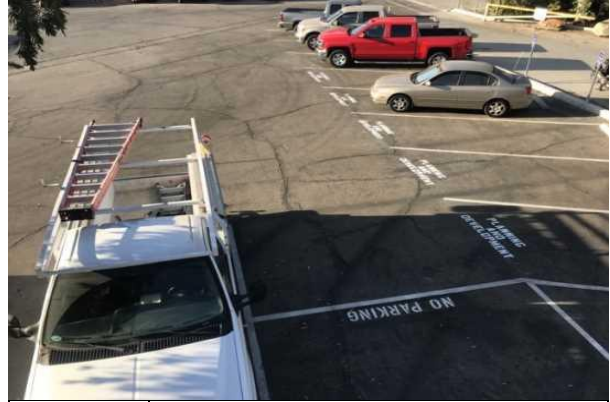
| #44 | CRACKING ASPHALT |
