# FACILITY CONDITION ASSESSMENT

**TRAINING AND SUPPORT SERVICES CENTER**  
3924 Riverview Drive  
Jurupa Valley, California 92509

January 28, 2020

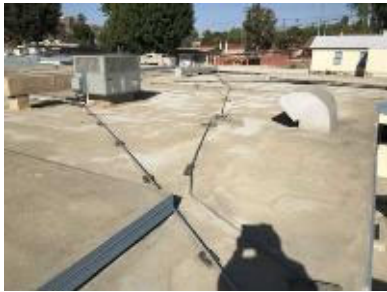
### Roof in Poor condition.

Built-Up  
Building 1: Rooms 1-7 Rooms #1-7 Roof

The existing roof is cracking, peeling and leaking throughout the roof. - AssetCALC ID: 1463506

Uniformat Code: B3011  
Recommendation: **Replace in 2020**

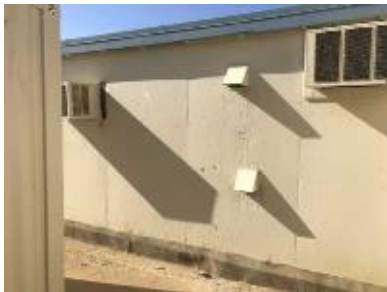
### Exterior Wall in Poor condition.

Plywood Siding, 1-2 Stories  
Building 1: Rooms 1-7 Room #2 Building Exterior

The existing wood facade is deteriorating and warped. - AssetCALC ID: 1463530

Uniformat Code: B2011  
Recommendation: **Replace in 2020**

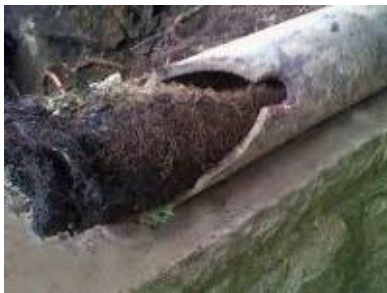
### Sanitary Sewer in Poor condition.

Video Scope  
Building 2: Room 10 Building #10

The client has reported sewer back-up issues at Room #10 on the hill. - AssetCALC ID: 1511454

Uniformat Code: G3029  
Recommendation: **Install in 2019**

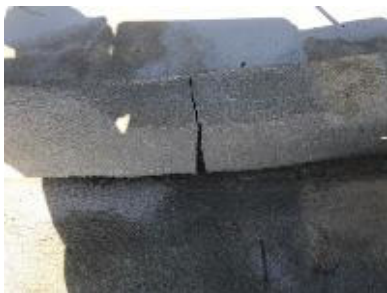
### HVAC System Ductwork in Poor condition.

Low Density  
Building 1: Rooms 1-7 Room #7 Roof

Rooftop duct piping is damaged. - AssetCALC ID: 1463548

Uniformat Code: D3041  
Recommendation: **Replace in 2019**

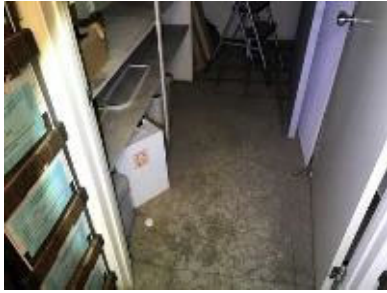
**Interior Floor Finish in Poor condition.**

Vinyl Tile (VCT) with Asbestos Abatement  
Building 1: Rooms 1-7 Room #6

The existing floor tile in this closet are asbestos. - AssetCALC ID: 1463524

Uniformat Code: C3024  
Recommendation: **Replace in 2020**

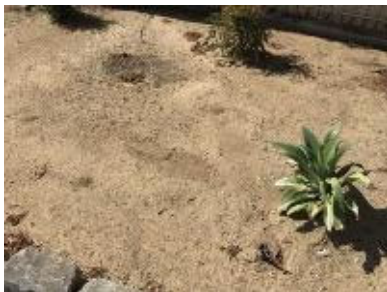
**Irrigation and Landscaping in Poor condition.**

Ground Cover  
Site Site

The client has reported irrigation systems coverage issues throughout the campus, and lack of landscape ground cover - AssetCALC ID: 1511453

Uniformat Code: G1031  
Recommendation: **Replace, and Re-establish in 2020**

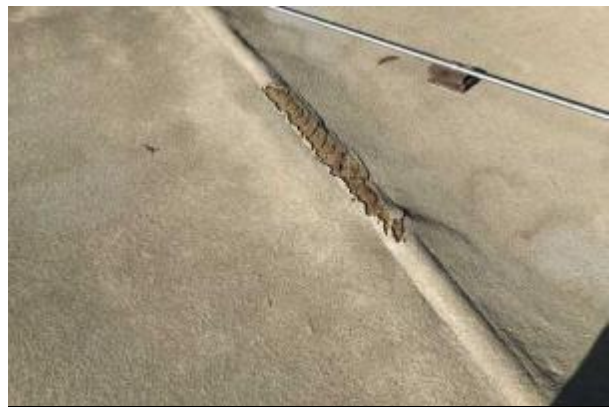
#10	BUILT-UP ROOFING, PEELING AND CRACKING
-----	--
