FACILITY CONDITION ASSESSMENT

October 29, 2019

EDUCATION CENTER-DISTRICT OFFICE
5960 Mustang Lane
Jurupa Valley, California 92509

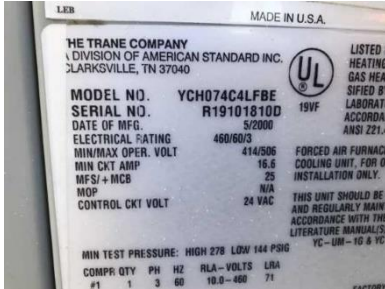
6 TON
Building A Building A Roof

Packaged Unit (RTU) in Poor condition.

Due to the condition and age of this unit the district is advising replacement of units for energy efficiency purposes - AssetCALC ID: 1463815

Uniformat Code: D3052
Recommendation: **Replace in 2020**

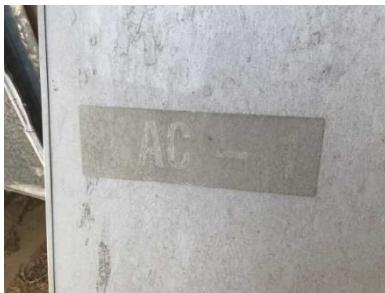
6 TON
Building A Building A Roof

Packaged Unit (RTU) in Poor condition.

Due to the condition and age of this unit the district is advising replacement of units for energy efficiency purposes - AssetCALC ID: 1463866

Uniformat Code: D3052
Recommendation: **Replace in 2020**

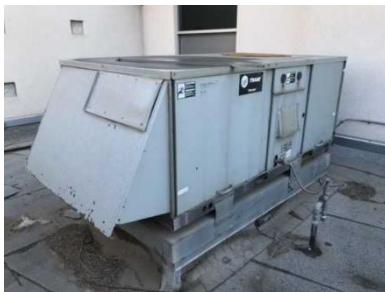
5 Ton
Building A Building A Roof

Packaged Unit (RTU) in Poor condition.

Due to the condition and age of this unit the district is advising replacement of units for energy efficiency purposes - AssetCALC ID: 1463805

Uniformat Code: D3052
Recommendation: **Replace in 2020**

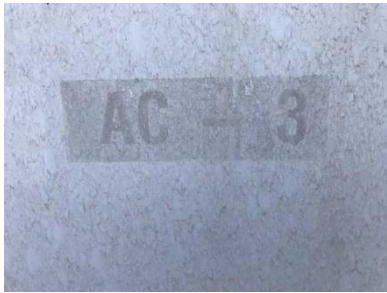
7.5 TON
Building A Building A Roof

Packaged Unit (RTU) in Poor condition.

Due to the condition and age of this unit the district is advising replacement of units for energy efficiency purposes - AssetCALC ID: 1463800

Uniformat Code: D3052
Recommendation: **Replace in 2020**

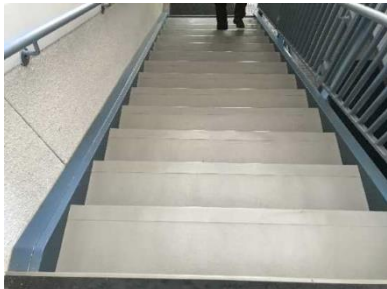
Raised Rubber Tile
Building A Building Stairwell

Interior Stair Treads in Fair condition.

Uniformat Code: C2021
Recommendation: **Replace in 2023**
