FACILITY CONDITION ASSESSMENT

October 28, 2019

CAMINO REAL ELEMENTARY SCHOOL
4655 Camino Real
Jurupa Valley, California 92509

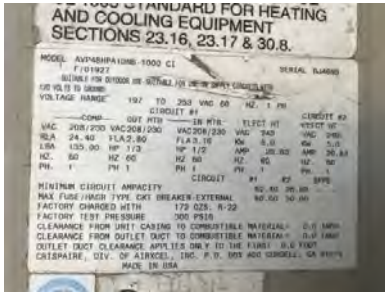
Heat Pump #27 in Poor condition.

Wall-Mounted, 3.5 to 4 Ton
 Portable Classroom #27 Portable Buildings 27
 Exterior

Due to the condition and age of this unit the district is advising replacement of units for energy efficiency purposes - AssetCALC ID: 1433615

Uniformat Code: D3052
 Recommendation: **Replace in 2020**

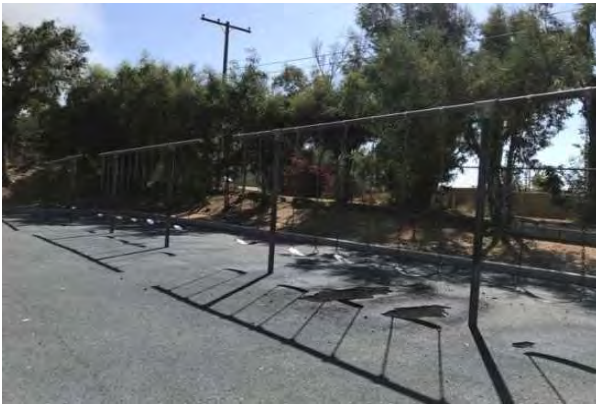
#45	PLAYGROUND SWING, DETERIORATING RUBBER SURFACE
-----	--

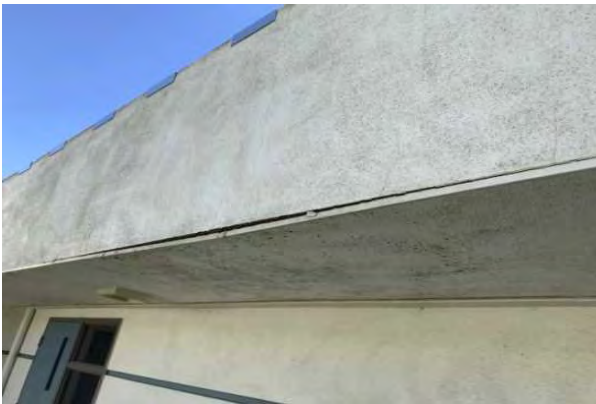
#47	WATER DAMAGED STUCCO FACADE
-----	-----------------------------
