FACILITY CONDITION ASSESSMENT

GRANITE HILL ELEMENTARY SCHOOL
9371 Granite Hill Drive
Jurupa Valley, California 92509

October 28, 2019

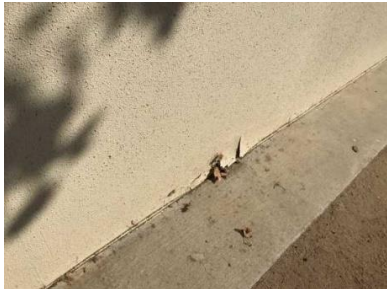
Stucco, 1-2 Stories
Classrooms #20-22 Classrooms 20-22

Exterior Wall in Poor condition.

There are several areas throughout the 6 buildings that the exterior wall surface is cracking, peeling and separating from the wall. - AssetCALC ID: 1447437

Uniformat Code: B2011
Recommendation: **Repair in 2019**

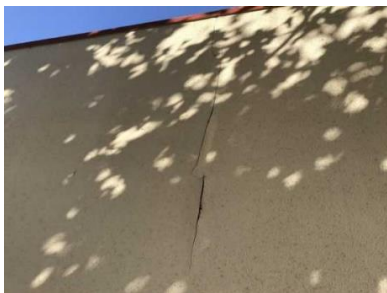
Stucco, 1-2 Stories
Classrooms #17-19 Classrooms 17-19

Exterior Wall in Poor condition.

There are several areas throughout the 6 buildings that the exterior wall surface is cracking, peeling and separating from the wall. - AssetCALC ID: 1434034

Uniformat Code: B2011
Recommendation: **Repair in 2019**

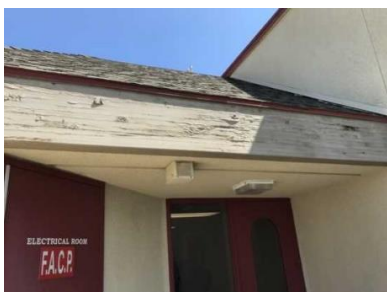
Exterior Building
Main Building Main Building Exterior

Wood Trim in Poor condition.

Exterior wood trim around the perimeter of the building is cracking and deteriorating. - AssetCALC ID: 1433954

Uniformat Code: B2011
Recommendation: **Replace in 2020**

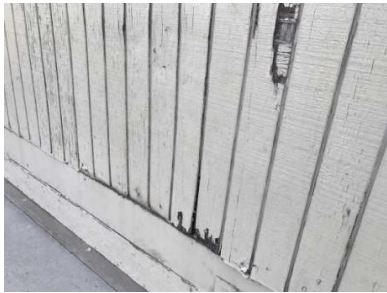
Wood Shakes/Shingles, 1-2 Stories
Portable Classroom #30 Portable Building 30
Exterior

Exterior Wall in Poor condition.

The existing wood fascia is cracking and peeling throughout the exterior of the building - AssetCALC ID: 1433970

Uniformat Code: B2011
Recommendation: **Replace in 2020**

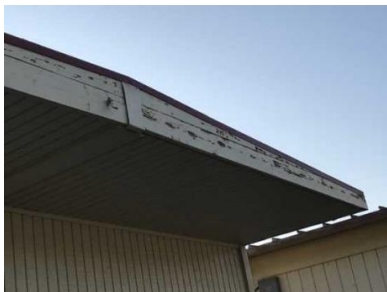
Exterior Building Envelope
Portable Classroom #30 Portable Building 30
Exterior

Wood Trim in Poor condition.

Existing wood trimming is cracking and peeling throughout exterior of building. - AssetCALC ID: 1433898

Uniformat Code: B2011
Recommendation: **Replace in 2020**

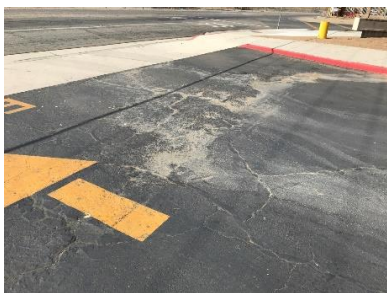
Asphalt Pavement
Site Site - Bus Entrance

Parking Lots in Poor condition.

This area is not stable and spider cracking throughout. - AssetCALC ID: 1431745

Uniformat Code: G2022
Recommendation: **Cut & Patch in 2019**

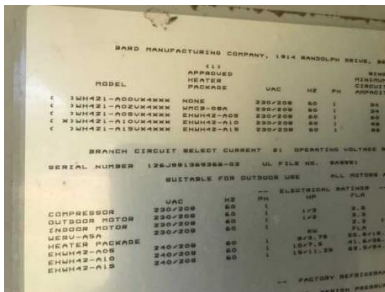
Heat Pump #29 in Poor condition.

Units area are past EUL and district is advising replacement of units for energy efficiency purposes. -
 AssetCALC ID: 1433956

Uniformat Code: D3052
 Recommendation: **Replace in 2020**

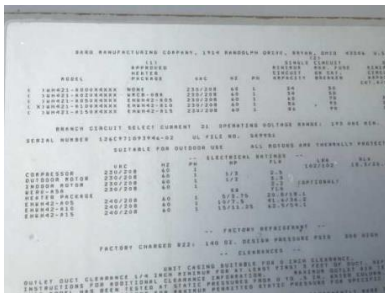
Heat Pump #24 in Poor condition.

Units area are past EUL and district is advising replacement of units for energy efficiency purposes. -
 AssetCALC ID: 1434011

Uniformat Code: D3052
 Recommendation: **Replace in 2020**

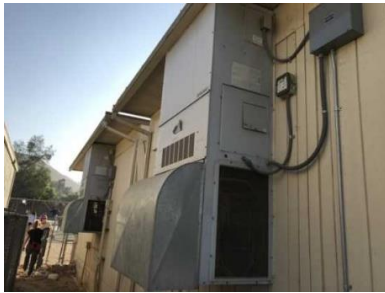
Wall-Mounted, 3.5 to 4 Ton
 Portable Classroom #25 Portable Building 25
 Exterior

Heat Pump #25 in Poor condition.

Units area are past EUL and district is advising replacement of units for energy efficiency purposes. -
 AssetCALC ID: 1433972

Uniformat Code: D3052
 Recommendation: **Replace in 2020**

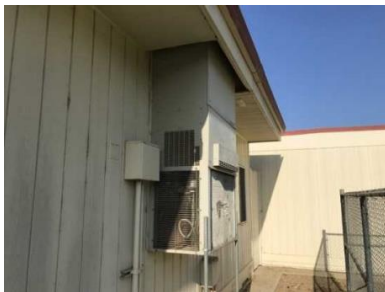
Wall-Mounted, 3.5 to 4 Ton
 Portable Classroom #28 Portable Building 28
 Exterior

Heat Pump #28 in Poor condition.

Units area are past EUL and district is advising replacement of units for energy efficiency purposes. -
 AssetCALC ID: 1434031

Uniformat Code: D3052
 Recommendation: **Replace in 2020**

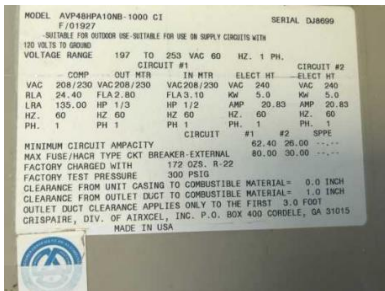
Wall-Mounted, 3.5 to 4 Ton
 Portable Classroom #27 Portable Building #27
 Exterior

Heat Pump #27 in Poor condition.

Units area are past EUL and district is advising replacement of units for energy efficiency purposes. -
 AssetCALC ID: 1433865

Uniformat Code: D3052
 Recommendation: **Replace in 2020**

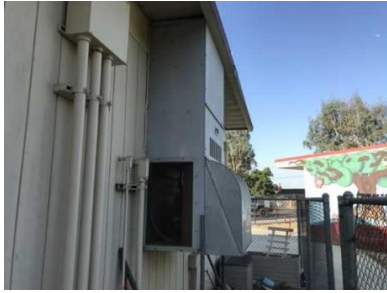
Wall-Mounted, 3.5 to 4 Ton
Portable Classroom #23 Portable Building #23
Exterior

Heat Pump #23 in Poor condition.

Units area are past EUL and district is advising replacement of units for energy efficiency purposes. -
AssetCALC ID: 1434086

Uniformat Code: D3052
Recommendation: **Replace in 2020**

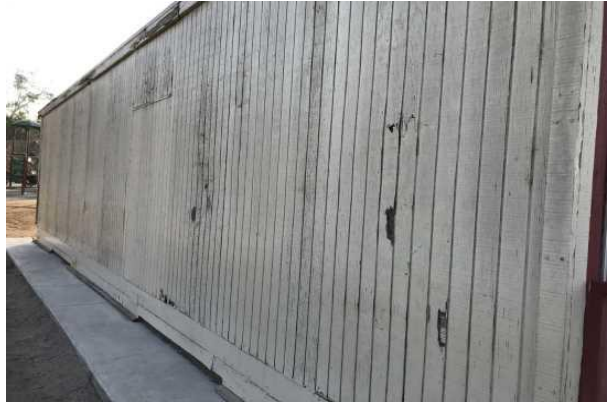
#14	DAMAGED WOOD FACADE
-----	---------------------

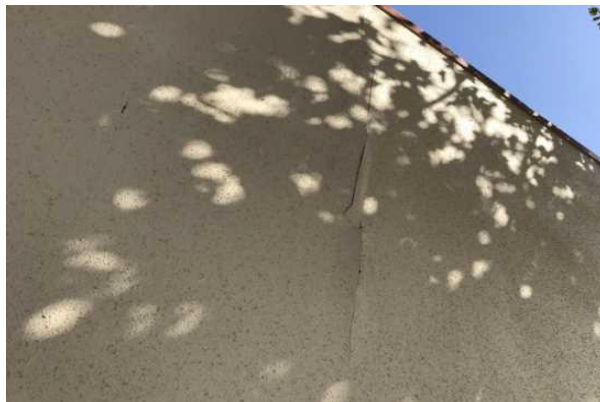
#15	DAMAGED EXTERIOR STUCCO FACADE
-----	--------------------------------

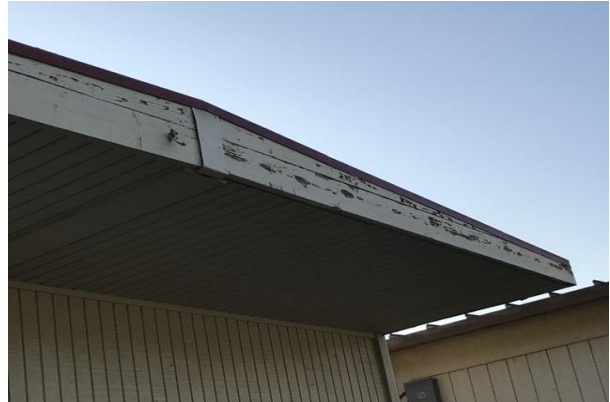
#50	PEELING AND CRACKING WOOD TRIMMING
-----	------------------------------------

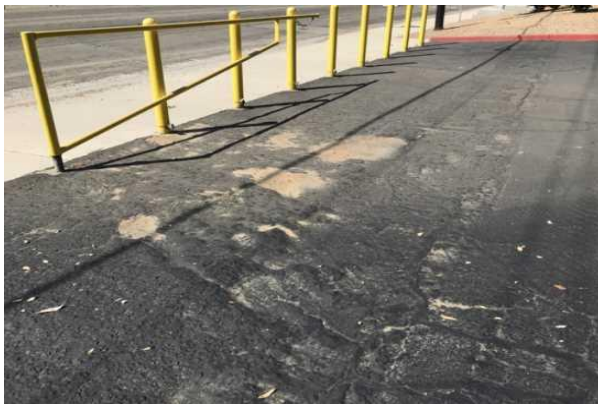
#51	DAMAGED ASPHALT SURFACE
-----	-------------------------

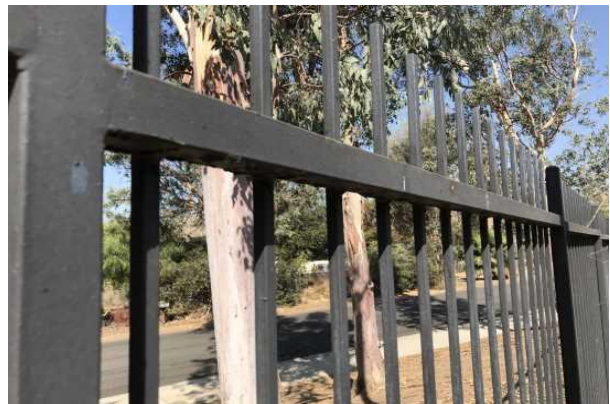
#52	PROPERTY FENCE FADING
-----	-----------------------
