FACILITY CONDITION ASSESSMENT

November 26, 2019

MISSION BELL ELEMENTARY SCHOOL
4020 Conning Street
Jurupa Valley, California 92509

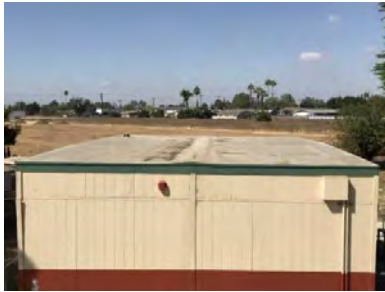
Modified Bituminous
Portable 30 Portable Classroom 30

**Roof in Failed condition.**

Leaking roof - AssetCALC ID: 1449223

Uniformat Code: B3011
Recommendation: **Replace in 2019**

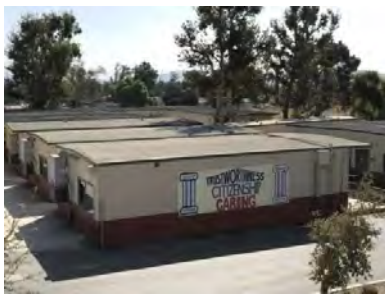
Modified Bituminous
Portable 22 Portable Classroom 22

**Roof in Poor condition.**

Roof leaks - AssetCALC ID: 1449359

Uniformat Code: B3011
Recommendation: **Replace in 2020**

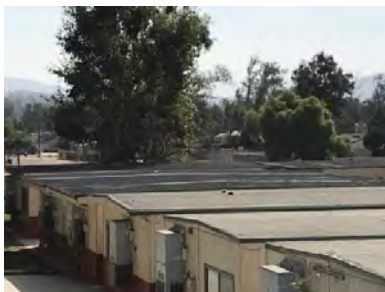
Metal
Portable 27 Portable Classroom 27

**Roof in Poor condition.**

Roof leaking - AssetCALC ID: 1449254

Uniformat Code: B3011
Recommendation: **Replace in 2020**

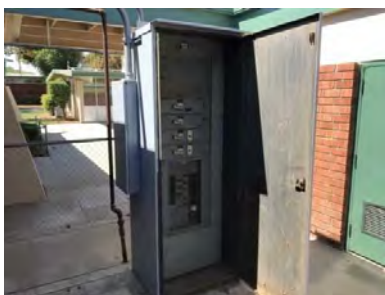
400 AMP
H - Classroom 12-17 Classroom 12-17

**Building/Main Switchboard in Failed condition.**

Unit is not in working condition - AssetCALC ID: 1449409

Uniformat Code: D5012
Recommendation: **Replace in 2019**

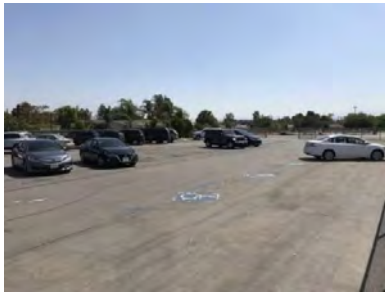
Asphalt Pavement
Site

Parking Lots in Poor condition.

Faded parking striping - AssetCALC ID: 1449172

Uniformat Code: G2022
Recommendation: **Seal and Stripe in 2020**

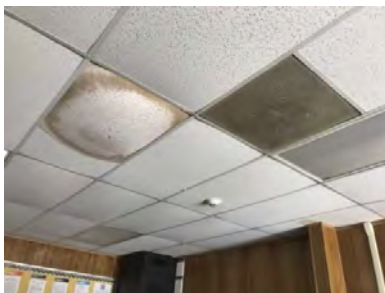
Suspended Acoustical Tile (ACT)
Portable 30 Portable Classroom 30

Interior Ceiling Finish in Failed condition.

Water damage - AssetCALC ID: 1449204

Uniformat Code: C3032
Recommendation: **Replace in 2019**

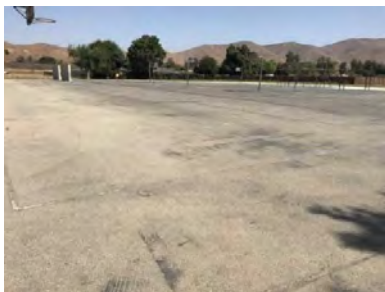
Asphalt
Site

Play Surfaces and Sports Courts in Poor condition.

Faded sports courts striping - AssetCALC ID: 1449454

Uniformat Code: G2047
Recommendation: **Seal and Stripe in 2020**

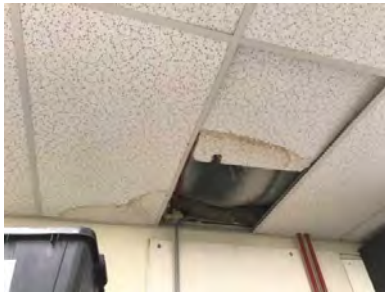
Suspended Acoustical Tile (ACT)
Portable 22 Portable Classroom 22

Interior Ceiling Finish in Poor condition.

Water stains - AssetCALC ID: 1449563

Uniformat Code: C3032
Recommendation: **Replace in 2021**

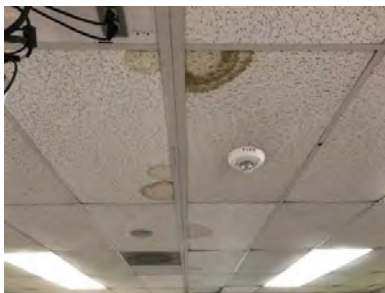
Suspended Acoustical Tile (ACT)
Portable 27 Portable Classroom 27

Interior Ceiling Finish in Poor condition.

Stained ceiling panels - AssetCALC ID: 1449427

Uniformat Code: C3032
Recommendation: **Replace in 2021**

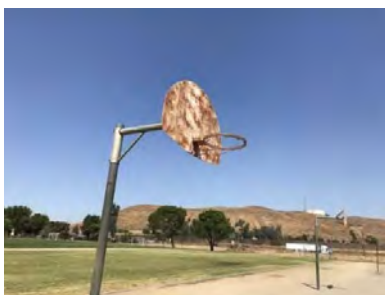
Basketball Backstop
Site

Sports Apparatus in Poor condition.

Rusted backboard - AssetCALC ID: 1449190

Uniformat Code: G2047
Recommendation: **Replace in 2020**

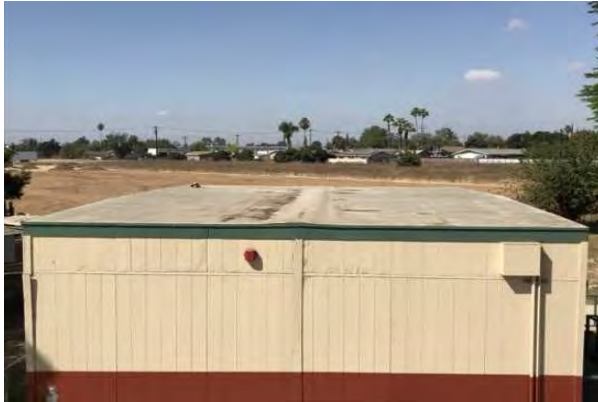
#25	DEFICIENCY - ROOF LEAK
-----	------------------------

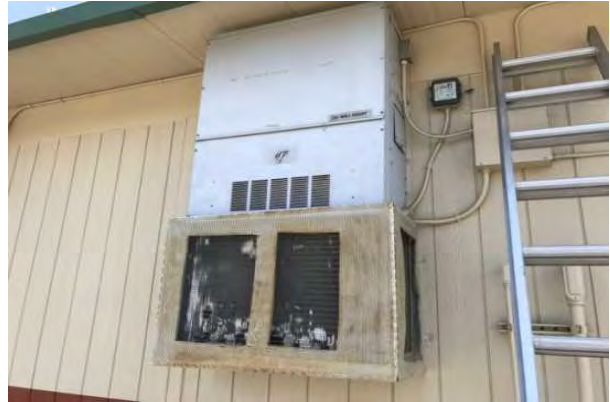
#26	DEFICIENCY - WALL MOUNTED HEAT PUMP UNIT
-----	--

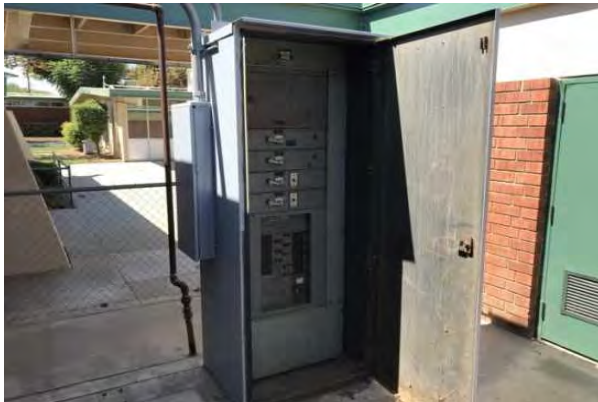
#27	DEFICIENCY - OUT OF SERVICE SWITCHBOARD
-----	---

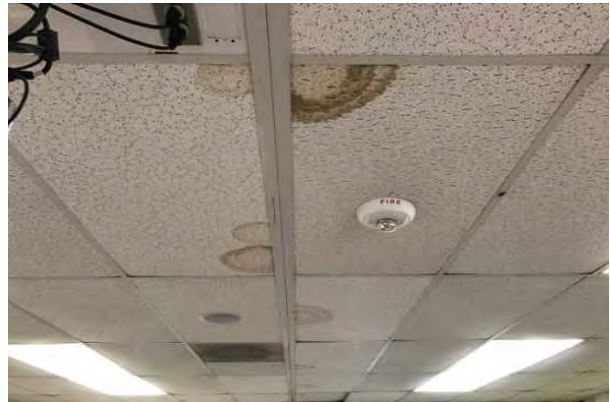
#28	DEFICIENCY - ROOF LEAK
-----	------------------------

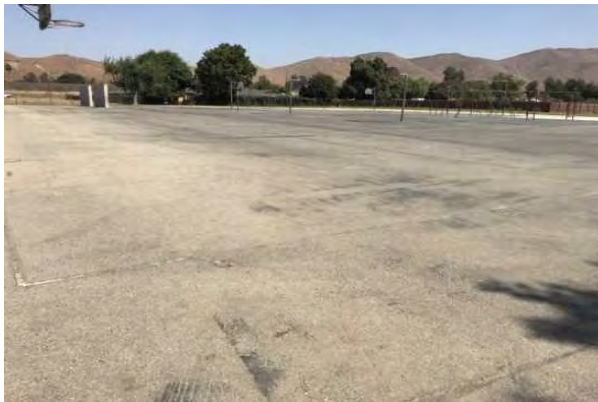
#29	DEFICIENCY - SPORTS COURTS FADED STRIPPING
-----	--

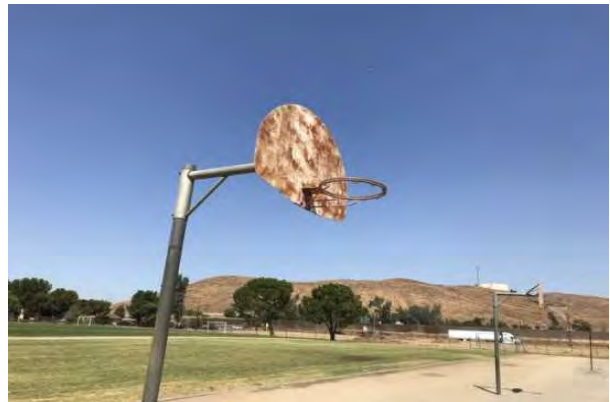
#30	DEFICIENCY - RUSTED BASKETBALL BACKBOARD
-----	--
