# FACILITY CONDITION ASSESSMENT

**TROTH STREET ELEMENTARY SCHOOL**  
5565 Troth Street  
Jurupa Valley, California 91752

139069.19R000-001.354

August 28, 2019

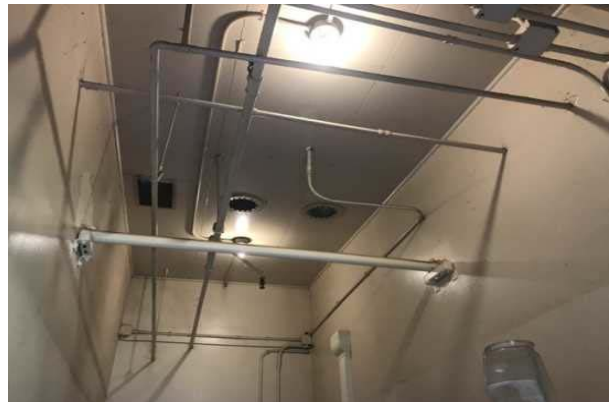
#30	PARTIAL SPRINKLER SYSTEM IN STORAGE CLOSET
-----	--

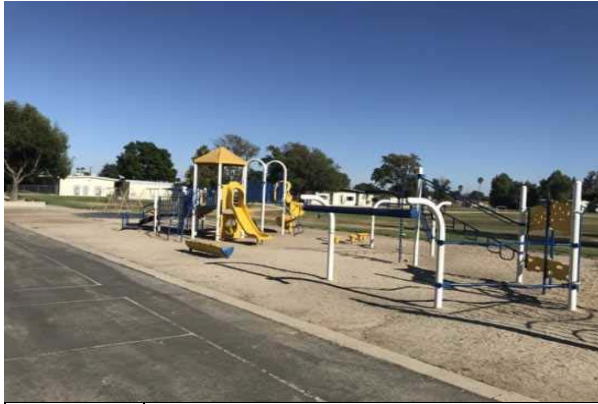
#43	NO ADA ACCESS TO PLAY STRUCTURES
-----	----------------------------------
