FACILITY CONDITION ASSESSMENT

October 30, 2019

PEDLEY ELEMENTARY SCHOOL
5871 Hudson Street
Jurupa Valley, California 92509

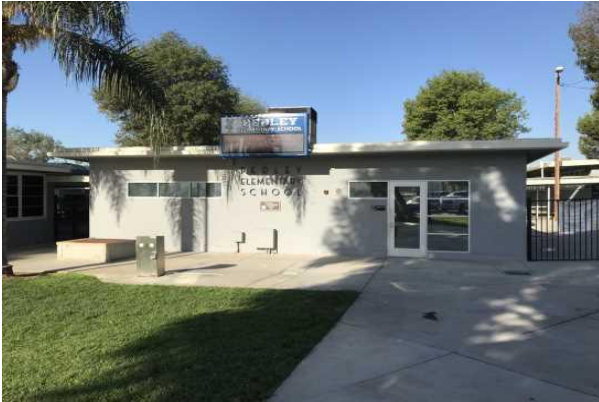
#1	ADMINISTRATION BUILDING EXTERIOR
----	----------------------------------

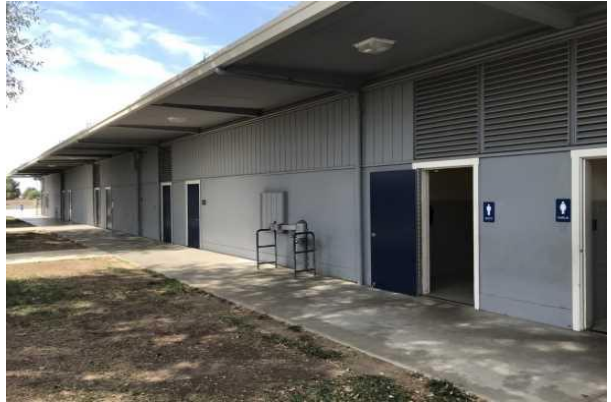
#2	CLASSROOMS BUILDING EXTERIOR
----	------------------------------

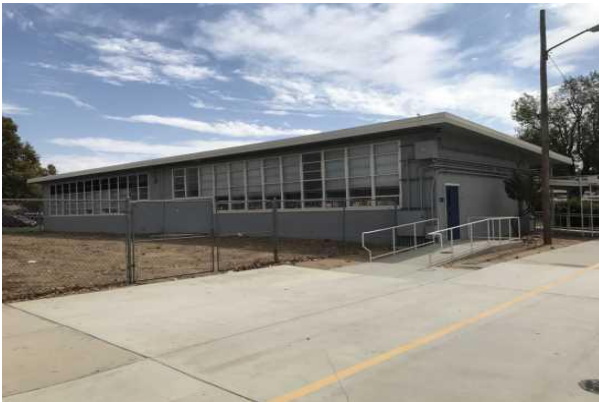
#3	CLASSROOMS BUILDING EXTERIOR
----	------------------------------

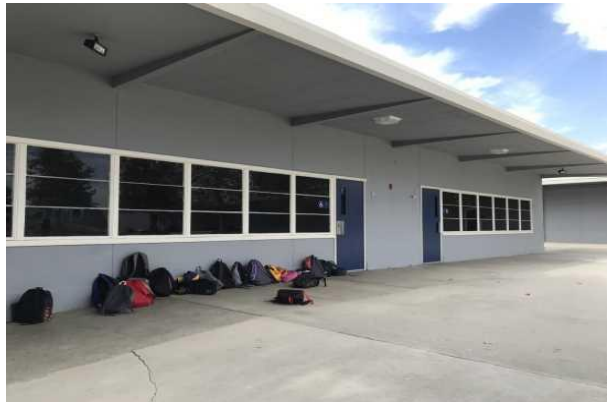
#4	CLASSROOMS BUILDING EXTERIOR
----	------------------------------

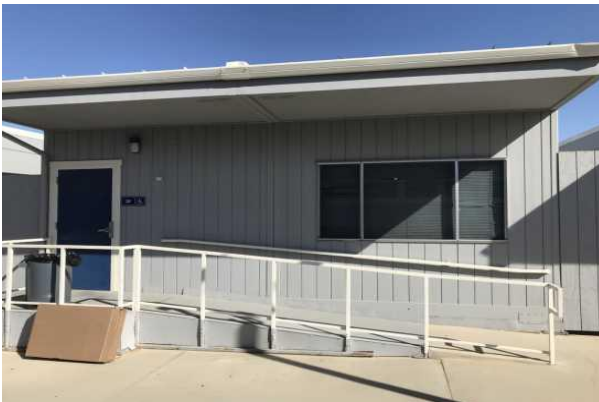
#5	PORTABLE CLASSROOM EXTERIOR
----	-----------------------------

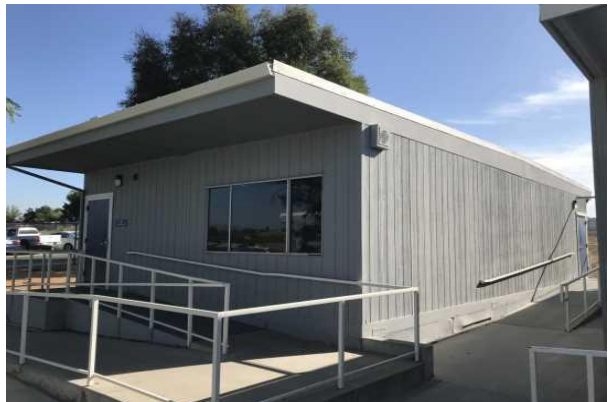
#6	PORTABLE CLASSROOM EXTERIOR
----	-----------------------------

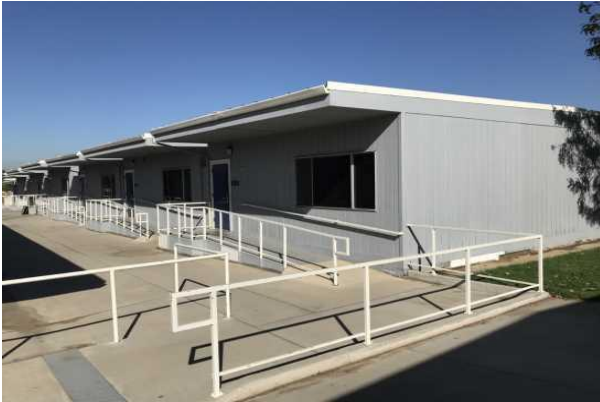
#7	PORTABLE CLASSROOM EXTERIOR
----	-----------------------------

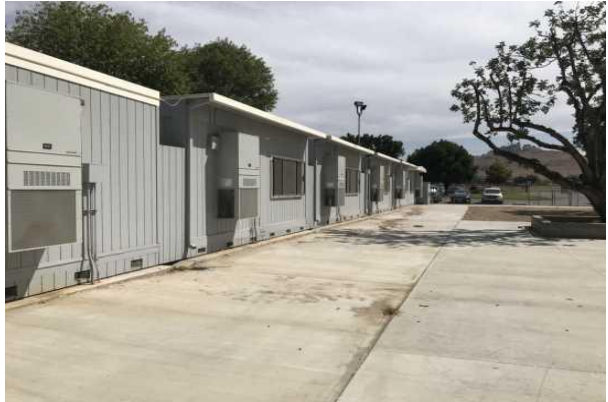
#8	PORTABLE CLASSROOM EXTERIOR
----	-----------------------------

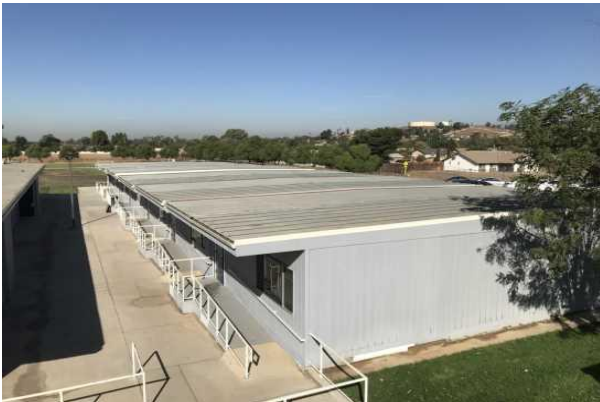
#9	PORTABLE CLASSROOM EXTERIOR
----	-----------------------------

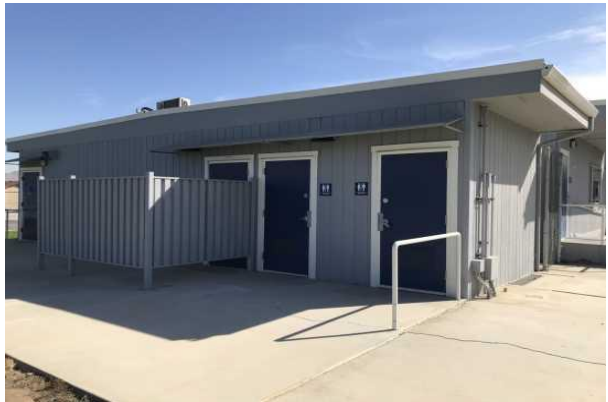
#10	RESTROOM BUILDING EXTERIOR
-----	----------------------------
