FACILITY CONDITION ASSESSMENT

October 22, 2019

PERALTA ELEMENTARY SCHOOL

6450 Peralta Place
Jurupa Valley, California 92509

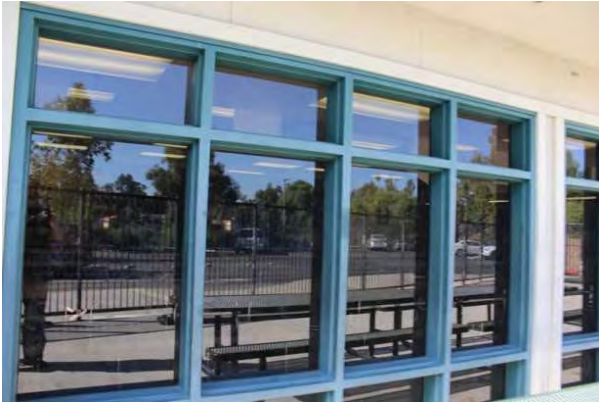
#13	STOREFRONT, METAL-FRAMED WINDOWS
-----	----------------------------------

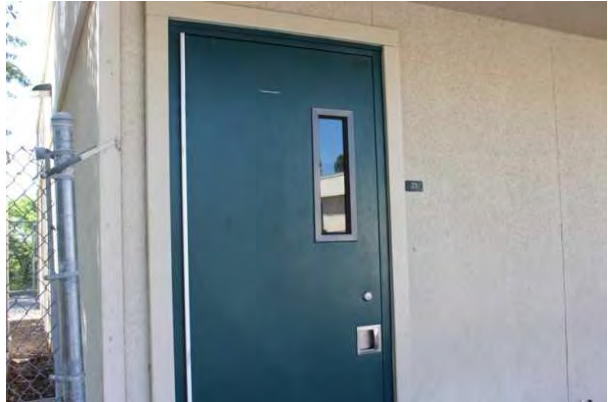
#14	EXTERIOR DOOR, STEEL
-----	----------------------

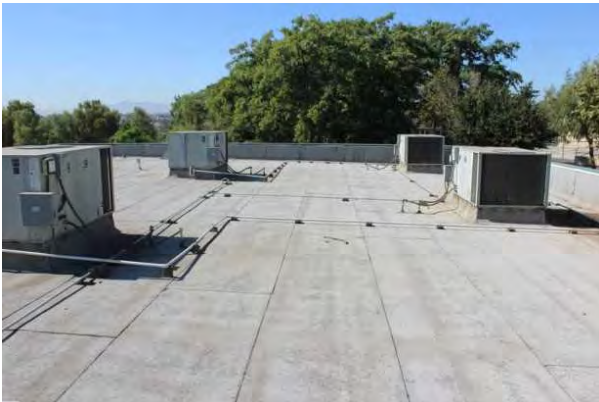
#15	ROOF, MODIFIED BITUMINOUS
-----	---------------------------

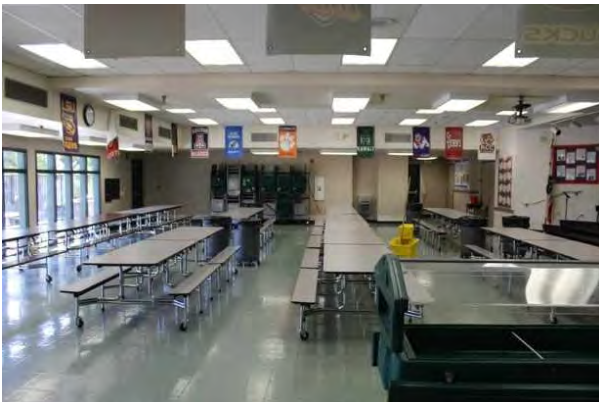
#17	INTERIOR FLOOR FINISH, VINYL TILE (VCT)
-----	---

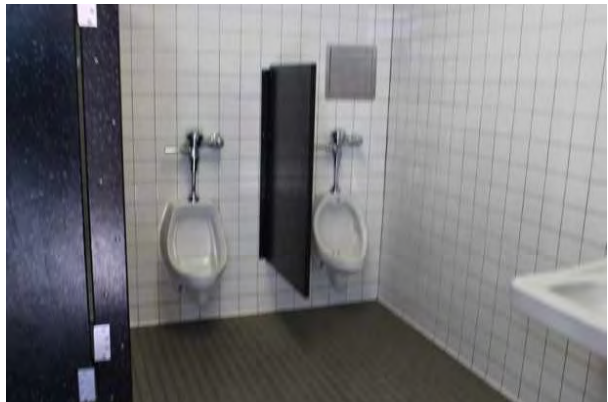
#18	INTERIOR FLOOR FINISH, CERAMIC TILE
-----	-------------------------------------

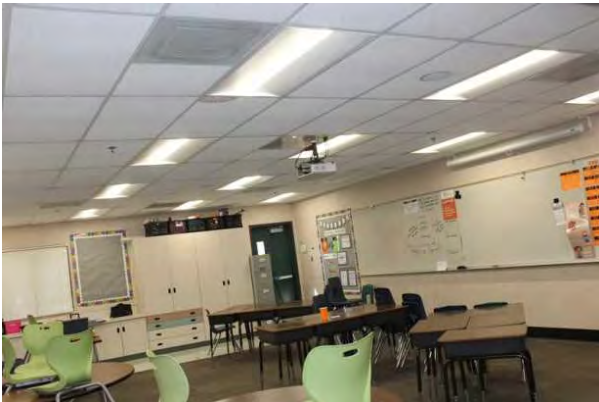
#21 INTERIOR CEILING FINISH, SUSPENDED ACOUSTICAL TILE (ACT)

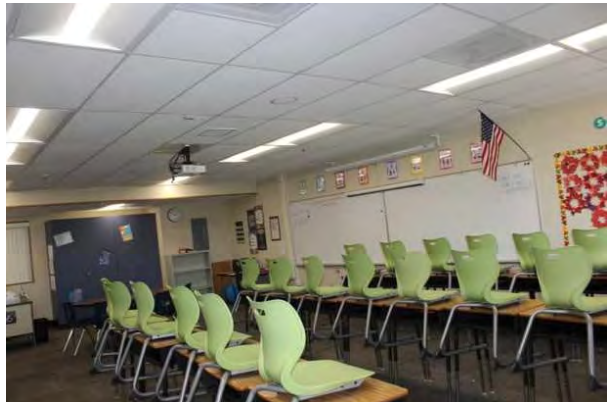
#22 INTERIOR CEILING FINISH, SUSPENDED ACOUSTICAL TILE (ACT)

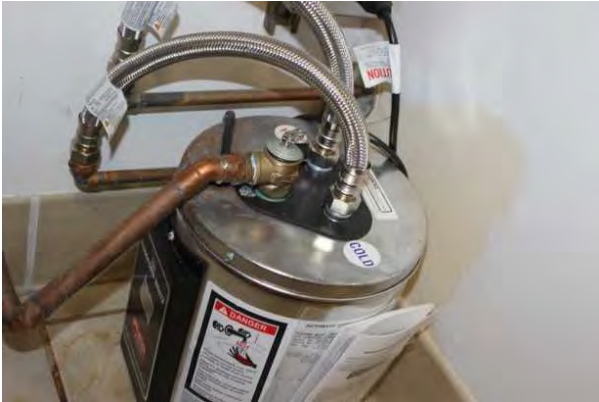
#30	WATER HEATER, ELECTRIC
-----	------------------------

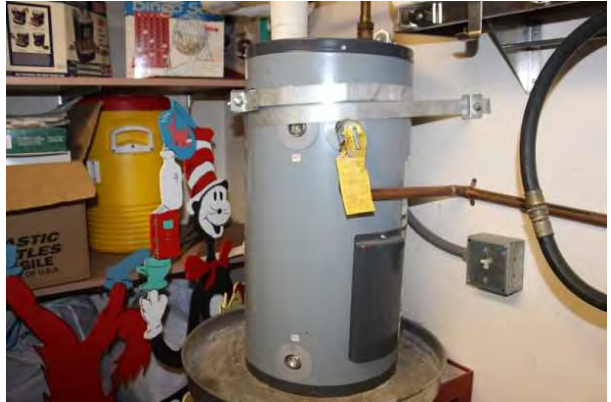
#31	WATER HEATER, ELECTRIC
-----	------------------------

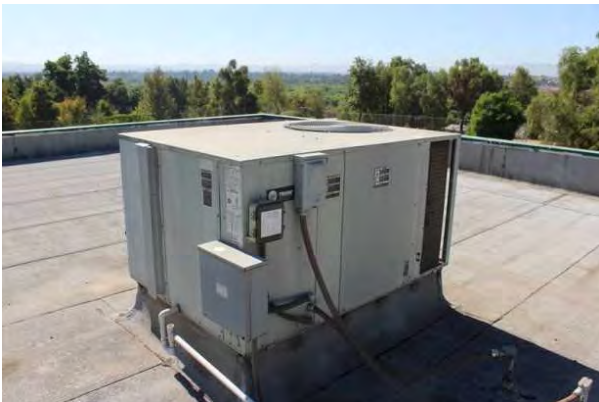
#34	PACKAGED UNIT (RTU)
-----	---------------------

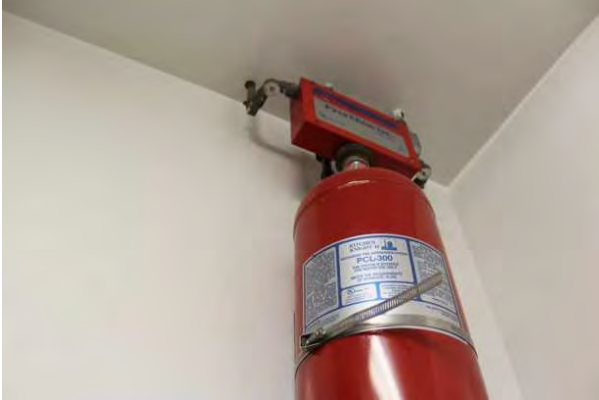
#36	FIRE EXTINGUISHER
-----	-------------------

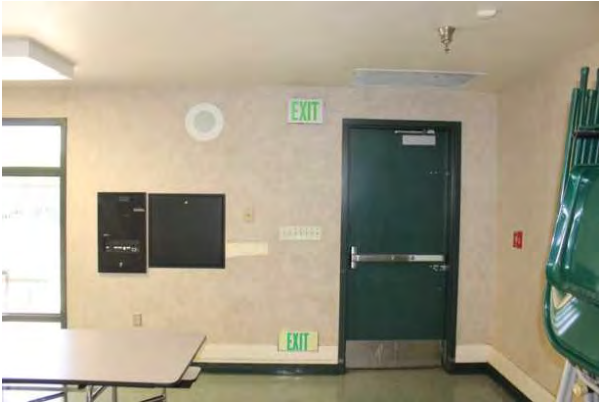
#42	FIRE ALARM CONTROL PANEL, ADDRESSABLE
-----	---------------------------------------

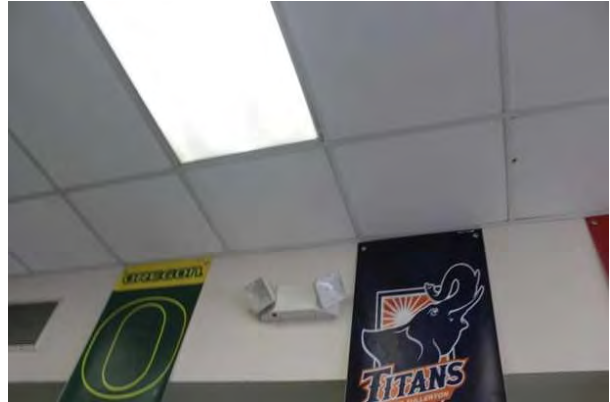
#43	EXIT SIGN LIGHT FIXTURE, LED
-----	------------------------------
