FACILITY CONDITION ASSESSMENT

VAN BUREN ELEMENTARY SCHOOL
9501 Jurupa Road
Jurupa Valley, California 92509

October 4, 2019

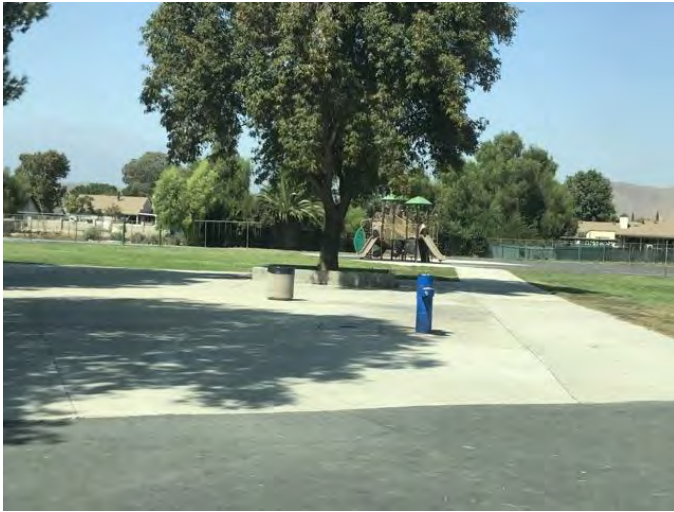
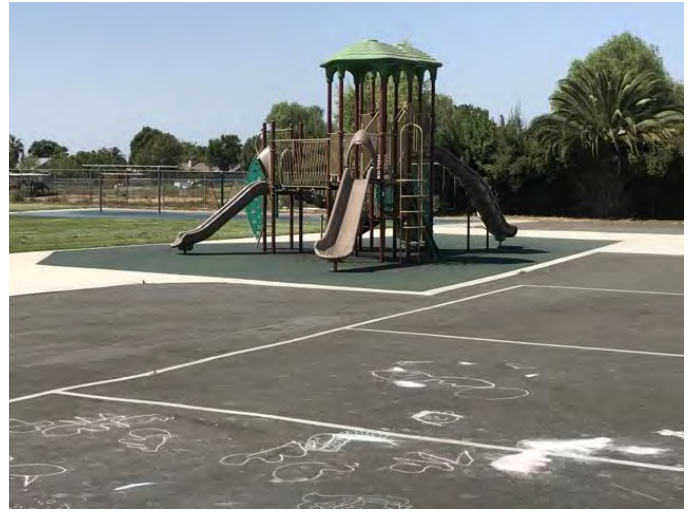
20. Site Summary

| Site Information | | |
|---|---|---|
| Key Issues and Findings | Missing signage at parking spaces, Surface wear and weathering at trash enclosure, repair section of the irrigation system. | |
