FACILITY CONDITION ASSESSMENT

January 14, 2020

WEST RIVERSIDE ELEMENTARY SCHOOL
3972 Riverview Drive
Jurupa Valley, California 92509

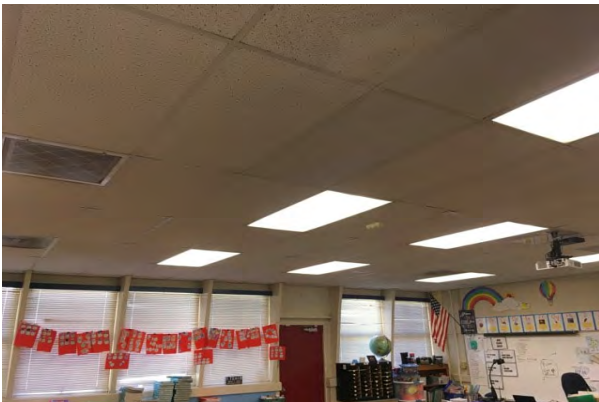
#22	INTERIOR CEILING FINISH, SUSPENDED ACOUSTICAL TILE (ACT)
-----	--

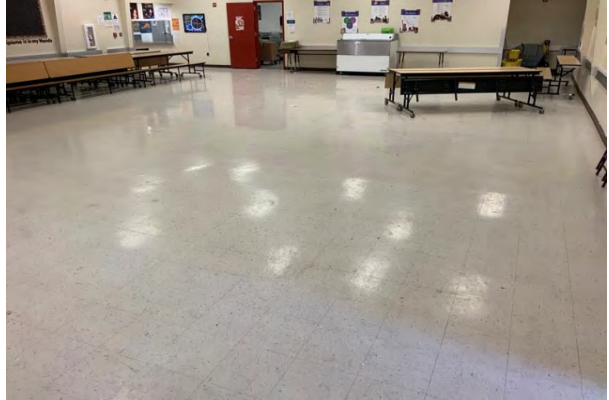
#25 DINING AREA IN CAFETERIA

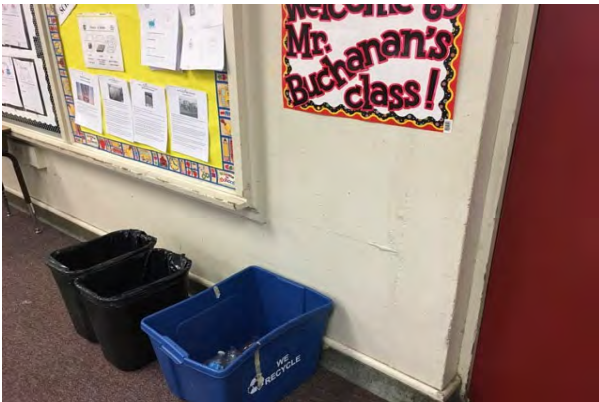
#28 INTERIOR WALL FINISH AND VCT TILE FLOORING

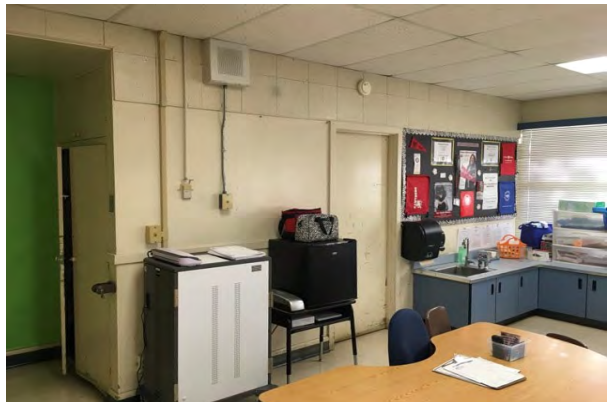
#29 INTERIOR WALL FINISH

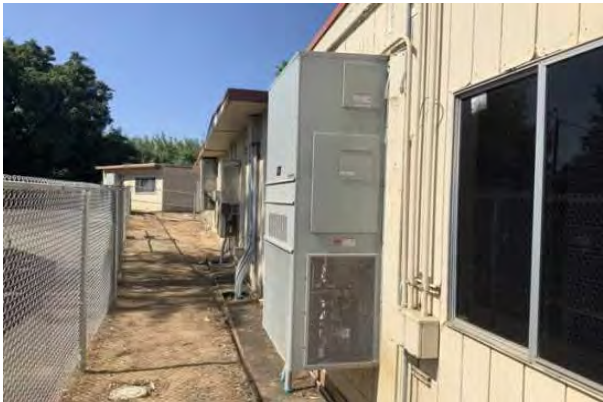
#45 PACKAGED UNIT
