FACILITY CONDITION ASSESSMENT

November 4, 2019

MIRA LOMA MIDDLE SCHOOL
5051 Steve Avenue
Jurupa Valley, California 92509

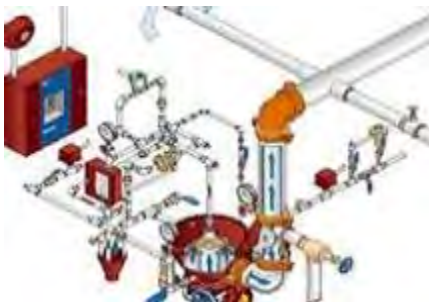
POC indicates coverage not adequate. - AssetCALC ID: 1465001

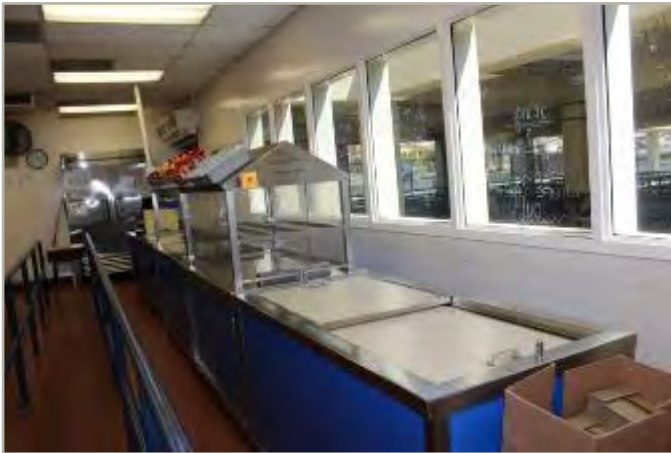
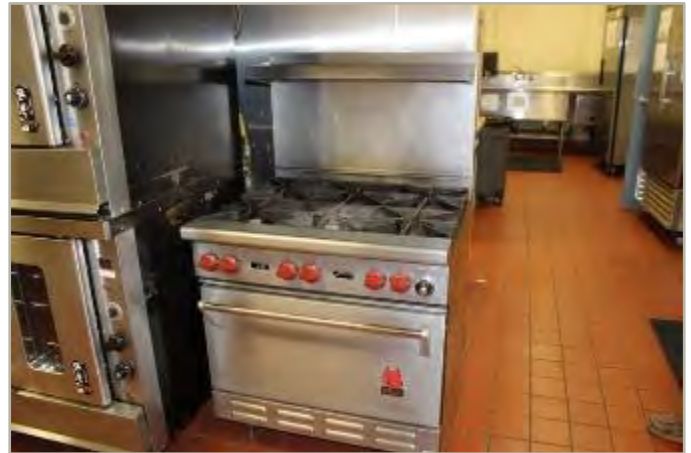
16. Kitchen

Address	5051 Steve Avenue, Jurupa Valley, California 92509	
Constructed/Renovated	1993	
Building Size	2,800 SF	
Number of Stories	One	
<i>System</i>	<i>Description</i>	<i>Condition</i>
Structure	Conventional wood frame structure on concrete slab	Good
Façade	Stucco with aluminum windows	Fair
Roof	Primary: Hip construction with asphalt shingles	Fair
Interiors	Walls: Painted gypsum board & ceramic tile Floors: VCT, ceramic tile, quarry tile Ceilings: Painted gypsum board, ACT	Fair
Elevators	None	--
Plumbing	Copper supply and cast-iron waste & venting Gas water heater Toilets and sinks in all restrooms	Fair

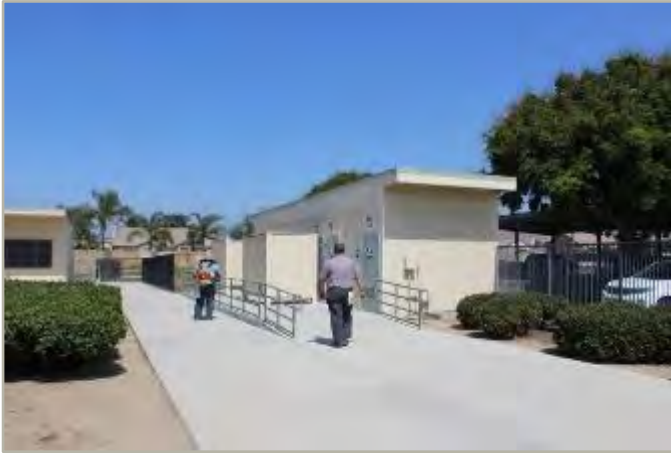
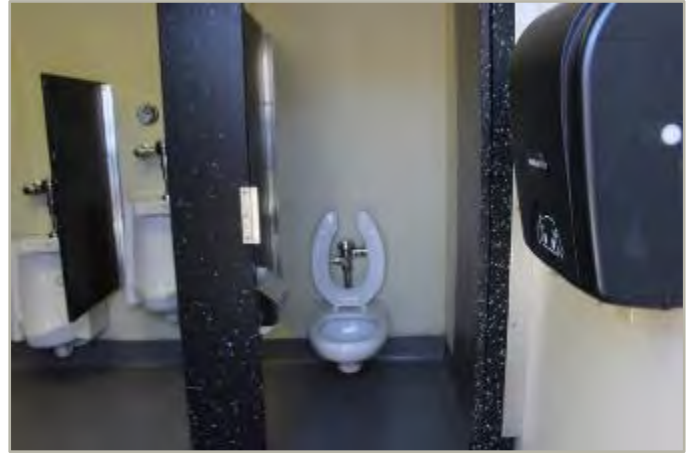
17. North Site Restrooms

Address	5051 Steve Avenue, Jurupa Valley, California 92509	
Constructed/Renovated	2003	
Building Size	500 SF	
Number of Stories	One	
<i>System</i>	<i>Description</i>	<i>Condition</i>
Structure	Conventional wood frame structure with raised floor	Good
Façade	Wood siding with steel doors	Fair
Roof	Primary: Flat construction with single-ply TPO/PVC membrane	Fair
Interiors	Walls: FRP panels Floors: Linoleum Ceilings: FRP panels	Fair
Elevators	None	--
Plumbing	Copper supply and cast-iron waste & venting No hot water Toilets, urinals, and sinks in all restrooms	Fair

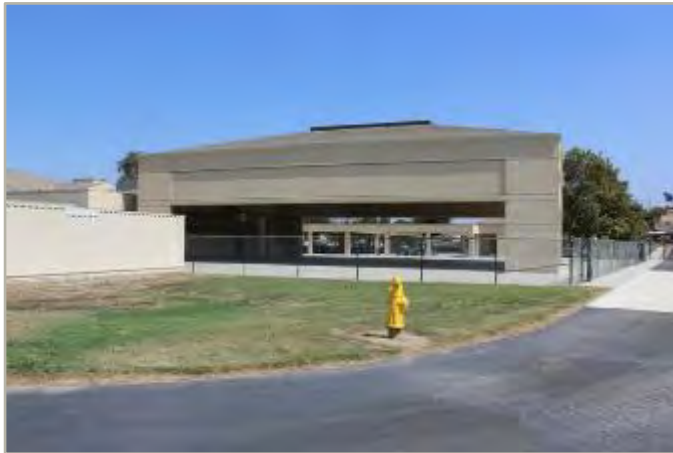
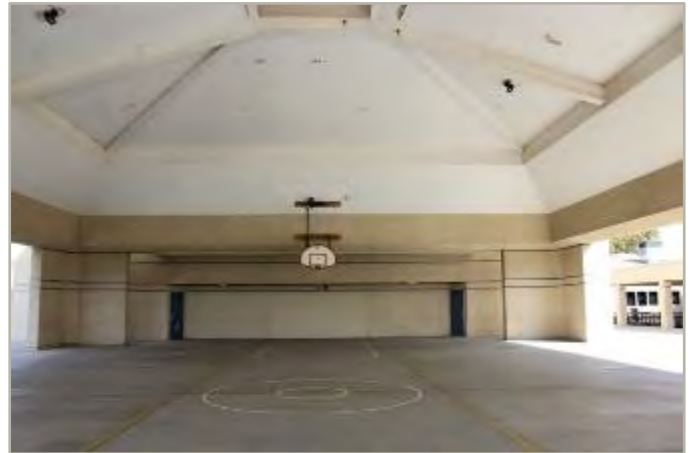
18. Outdoor Basketball Court

Address	5051 Steve Avenue, Jurupa Valley, California 92509	
Constructed/Renovated	1993	
Building Size	6,000 SF	
Number of Stories	One	
<i>System</i>	<i>Description</i>	<i>Condition</i>
Structure	Steel frame with concrete-topped metal decks	Good
Façade	Stucco	Fair
Roof	Primary: Hip construction with asphalt shingles	Fair
Interiors	Walls: Painted gypsum board Floors: Unfinished Ceilings: Painted gypsum board	Fair
Elevators	None	--
Plumbing	None	--

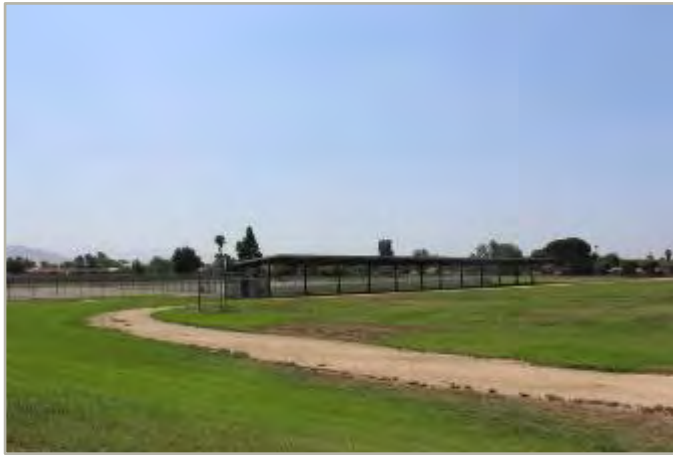
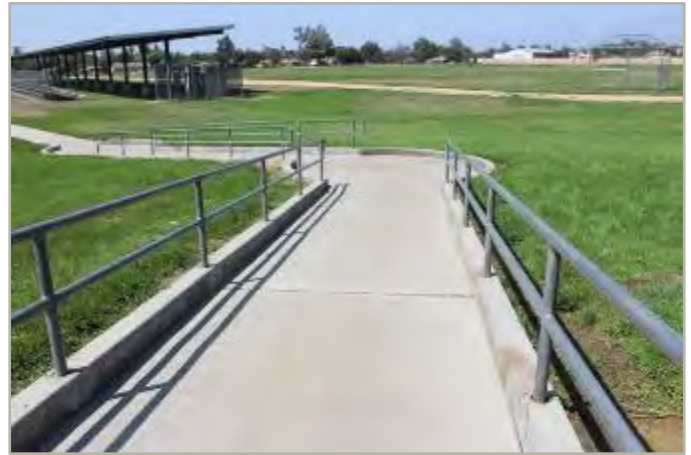
19. Site Summary

Lot Size	23.7 acres (estimated)	
Parking Spaces	150 total spaces all in open lots; 7 of which are accessible	
<i>System</i>	<i>Description</i>	<i>Condition</i>
Pavement/Flatwork	Asphalt lots with areas of concrete and concrete sidewalks, curbs, ramps, and stairs	Good
Site Development	Building-mounted, Property entrance signage, chain link fencing, CMU dumpster enclosures Playgrounds and sports courts with bleachers, fencing Heavily furnished picnic tables, trash receptacles	Fair
Landscaping and Topography	Limited landscaping features Irrigation present	Poor
Utilities	Municipal water and sewer Local utility-provided electric and natural gas	Good
Site Lighting	Pole-mounted: LED Building-mounted: LED	Good
Ancillary Structures	None	--
Key Issues and Findings	POC indicates inadequate irrigation coverage
