FACILITY CONDITION ASSESSMENT

November 14, 2019

MISSION MIDDLE SCHOOL
5961 Mustang Lane
Jurupa Valley, California 92509

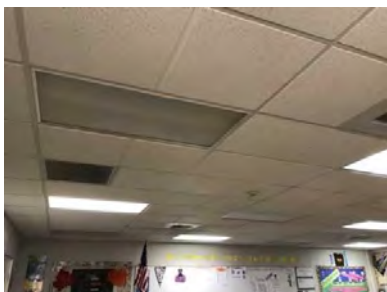
There is no sprinkler system installed in this building. - AssetCALC ID: 1474306

Uniformat Code: D4019
Recommendation: **Renovate in 2024**

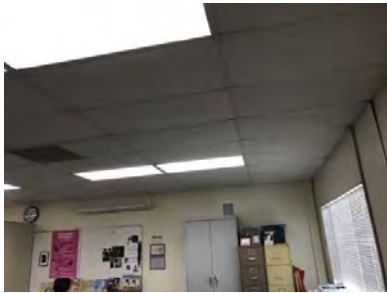
Full Retrofit, Low Density/Complexity
Portable Building #32 Portable Building #32

There is no sprinkler system installed in this building. - AssetCALC ID: 1474472

Uniformat Code: D4019
Recommendation: **Renovate in 2024**

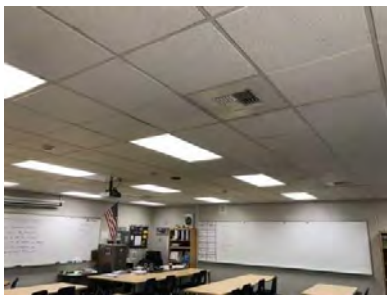
Full Retrofit, Medium Density/Complexity
Classroom Building #13-20 Classroom Building #13-20

There is no sprinkler system installed in this building. - AssetCALC ID: 1474291

Uniformat Code: D4019
Recommendation: **Renovate in 2024**

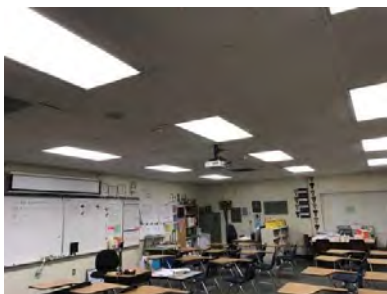
Full Retrofit, Low Density/Complexity
Portable Building #35 Portable Building #35

There is no sprinkler system installed in this building. - AssetCALC ID: 1474389

Uniformat Code: D4019
Recommendation: **Renovate in 2024**

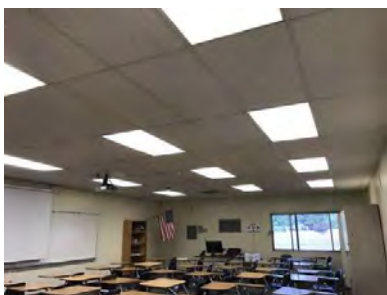
Full Retrofit, Low Density/Complexity
Portable Building #37 Portable Building #37

There is no sprinkler system installed in this building. - AssetCALC ID: 1474305

Uniformat Code: D4019
Recommendation: **Renovate in 2024**

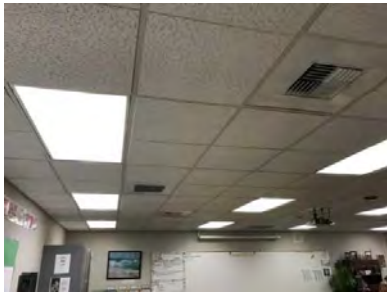
Full Retrofit, Medium Density/Complexity
Classroom Building #7-10 Classroom Building #7-10

There is no sprinkler system installed in this building. - AssetCALC ID: 1474536

Uniformat Code: D4019
Recommendation: **Renovate in 2024**

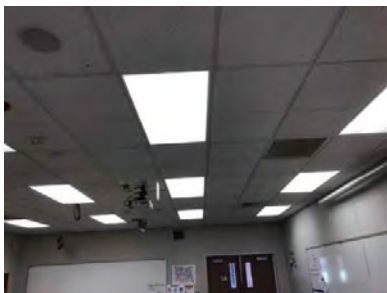
Full Retrofit, Medium Density/Complexity
Main Office Building Main Office Building

There is no sprinkler system installed in this building. - AssetCALC ID: 1474223

Uniformat Code: D4019
Recommendation: **Renovate in 2024**

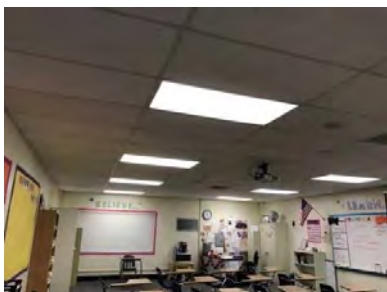
Full Retrofit, Low Density/Complexity
Portable Building #39 Portable Building #39

There is no sprinkler system installed in this building. - AssetCALC ID: 1474308

Uniformat Code: D4019
Recommendation: **Renovate in 2024**

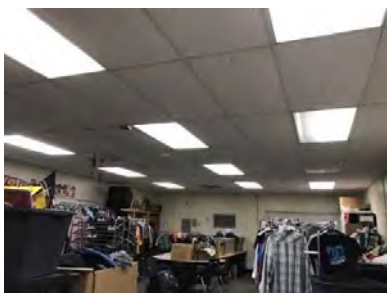
Full Retrofit, Low Density/Complexity
Portable Building #34 Portable Building #34

There is no sprinkler system installed in this building. - AssetCALC ID: 1474377

Uniformat Code: D4019
Recommendation: **Renovate in 2024**

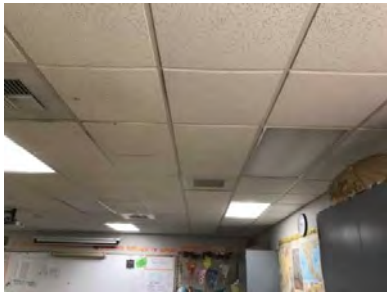
Full Retrofit, Medium Density/Complexity
Classroom Building #26-29 Classroom Building #26-29

There is no sprinkler system installed in this building. - AssetCALC ID: 1474202

Uniformat Code: D4019
Recommendation: **Renovate in 2024**

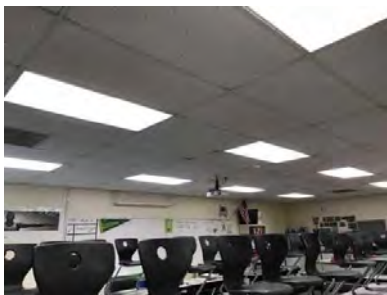
Full Retrofit, Low Density/Complexity
Portable Building #36 Portable Building #36

There is no sprinkler system installed in this building. - AssetCALC ID: 1474387

Uniformat Code: D4019
Recommendation: **Renovate in 2024**

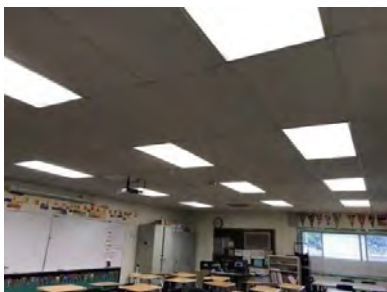
Full Retrofit, Low Density/Complexity
Portable Building #33 Portable Building #33

There is no sprinkler system installed in this building. - AssetCALC ID: 1474471

Uniformat Code: D4019
Recommendation: **Renovate in 2024**
