FACILITY CONDITION ASSESSMENT

October 7, 2019

THE LEARNING CENTER - ADULT EDUCATION
4041 Pacific Avenue
Jurupa Valley, California 92509

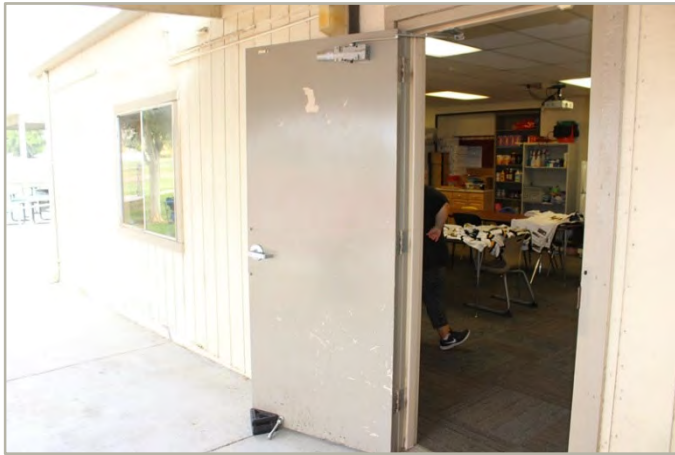
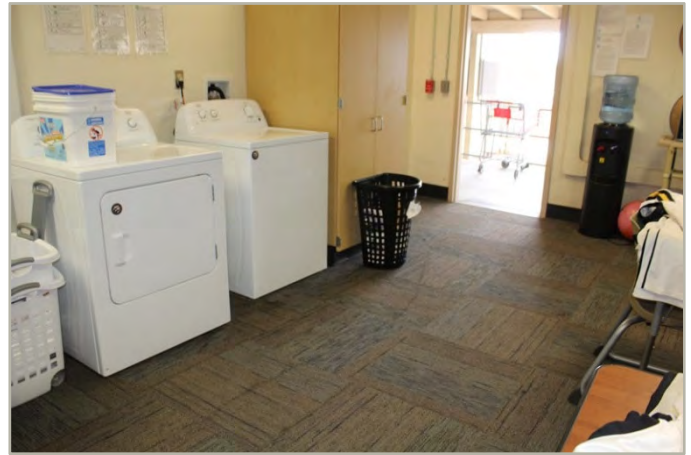
4. Portable – Room 1

HVAC	Wall mounted heat pumps	Fair
Fire Suppression	Hydrants, fire extinguishers	Fair
Electrical	Source and Distribution: Main panel with copper wiring Interior Lighting: T-8	Fair
Fire Alarm	Smoke detectors, alarms, strobes, pull stations, back-up emergency lights, and exit signs	Fair
Equipment/Special	None	--
Accessibility	Presently it does not appear an accessibility study is needed for this property.	
Key Issues and Findings	Building lacks fire suppression, roof is leaking

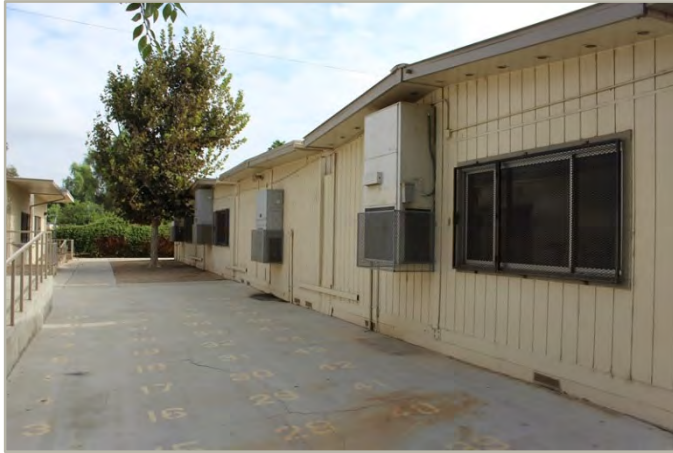
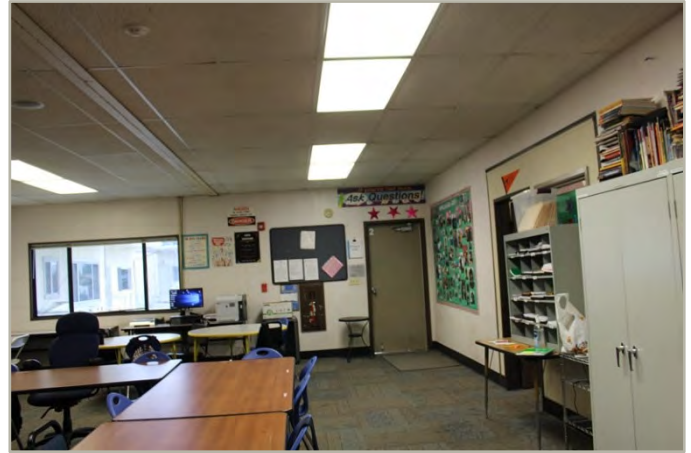
5. Portable – Room 2

Portable – Room 2: Systems Summary		
HVAC	Wall mounted heat pump	Fair
Fire Suppression	Hydrants, fire extinguishers	Fair
Electrical	Source and Distribution: Main panel with copper wiring Interior Lighting: T-8	Fair
Fire Alarm	Smoke detectors, alarms, strobes, pull stations, back-up emergency lights, and exit signs	Fair
Equipment/Special	None	--
Accessibility	Presently it does not appear an accessibility study is needed for this property.	
Key Issues and Findings	Building lacks fire suppression, roof leaks

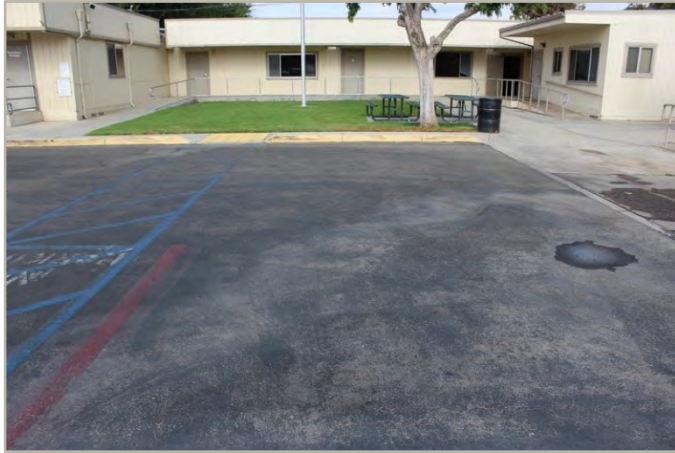
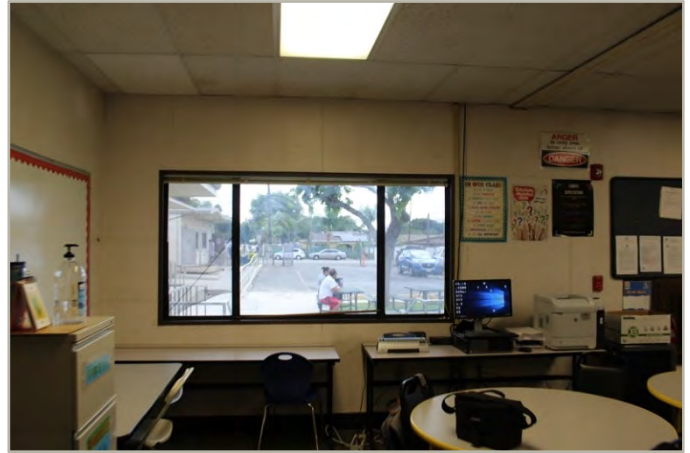
6. Portable – Room 3

Portable – Room 3: Systems Summary		
HVAC	Wall mounted heat pump	Fair
Fire Suppression	Hydrants, fire extinguishers	Fair
Electrical	Source and Distribution: Main panel with copper wiring Interior Lighting: T-8	Fair
Fire Alarm	Smoke detectors, alarms, strobes, pull stations, back-up emergency lights, and exit signs	Fair
Equipment/Special	None	--
Accessibility	Presently it does not appear an accessibility study is needed for this property.	
Key Issues and Findings	Building lacks fire suppression, roof leaks, needs replacement

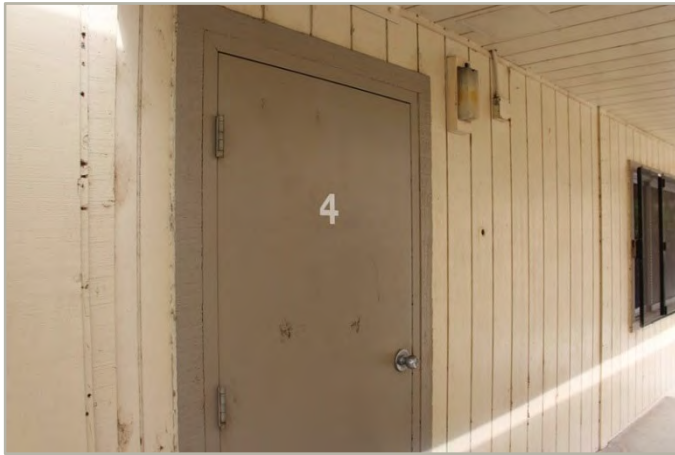
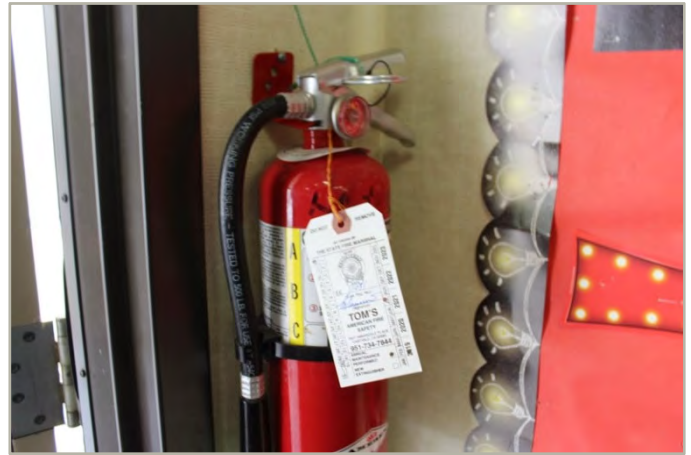
7. Portable – Room 4

HVAC	Wall mounted heat pump	Fair
Fire Suppression	Hydrants, fire extinguishers	Fair
Electrical	Source and Distribution: Main panel with copper wiring Interior Lighting: T-8	Fair
Fire Alarm	Alarm panel, smoke detectors, alarms, strobes, pull stations, back-up emergency lights, and exit signs	Fair
Equipment/Special	None	--
Accessibility	Presently it does not appear an accessibility study is needed for this property.	
Key Issues and Findings	Building lacks fire suppression, roof leaks, needs replacement

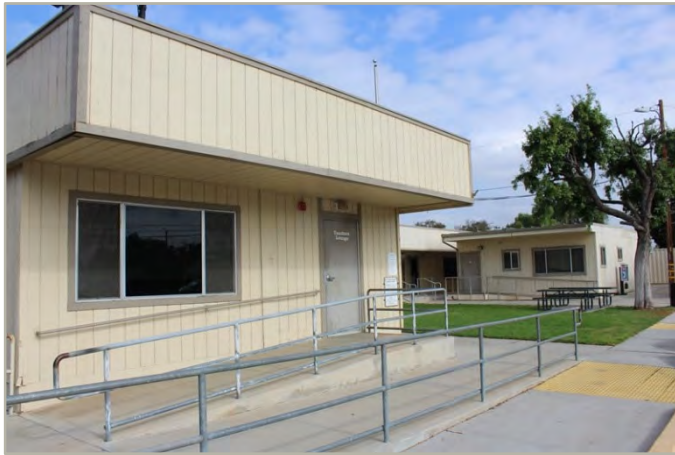
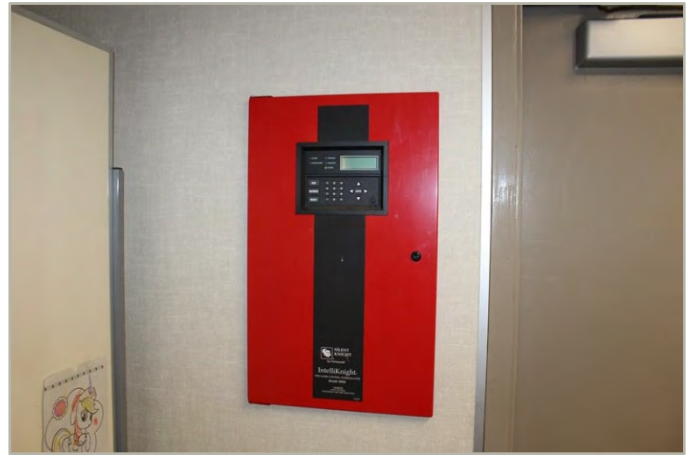
14. Portable – Staff Lounge

HVAC	Wall mounted heat pump	Fair
Fire Suppression	Hydrants, fire extinguishers	Fair
Electrical	Source and Distribution: Main panel with copper wiring Interior Lighting: T-8	Fair
Fire Alarm	Alarm panel, smoke detectors, alarms, strobes, pull stations, back-up emergency lights, and exit signs	Fair
Equipment/Special	None	--
Accessibility	Presently it does not appear an accessibility study is needed for this property.	
Key Issues and Findings	Building lacks fire suppression, roof leaking

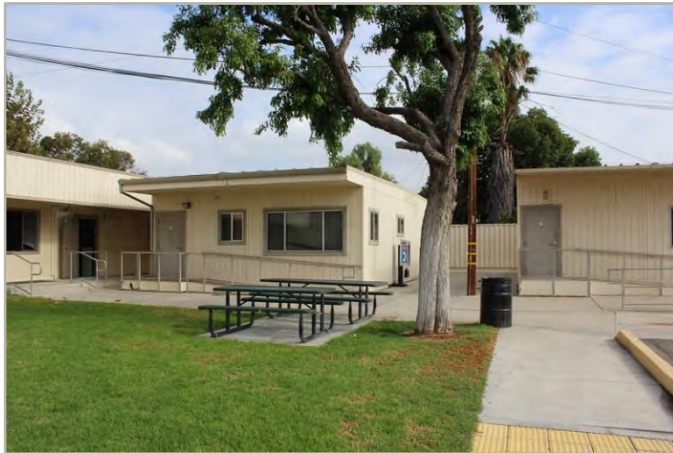
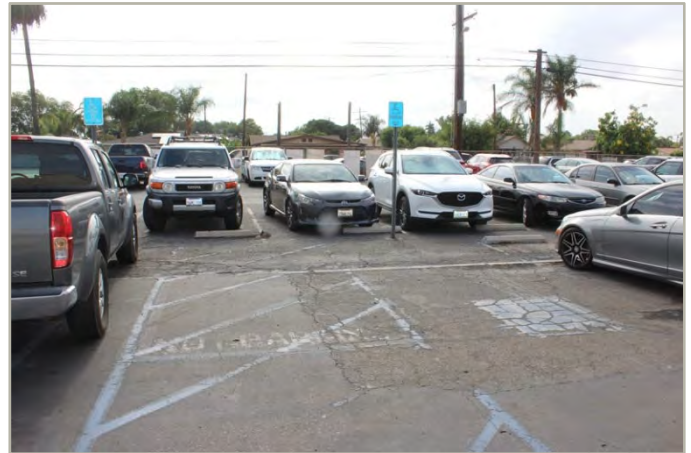
15. Site Summary

Site Information		
Lot Size	1.29 acres (estimated)	
Parking Spaces	31 total spaces all in open lots; 3 of which are accessible	
<i>System</i>	<i>Description</i>	<i>Condition</i>
Pavement/Flatwork	Asphalt lots with areas of concrete and concrete sidewalks, curbs, ramps, and stairs	Poor
Site Development	Building-mounted signage, chain link fencing, Limited park benches, picnic tables, trash receptacles	Fair
Landscaping and Topography	No significant landscaping features Irrigation present	Fair
Utilities	Municipal water and sewer Local utility-provided electric	Good
Site Lighting	Pole-mounted: LED Building-mounted: metal halide	Fair
Ancillary Structures	Patio structure attached to Restrooms building	--
Key Issues and Findings	Heavy asphalt wear, severe alligator cracking and potholes
