FACILITY CONDITION ASSESSMENT

HMC Architects JURUPA UNIFIED SCHOOL DISTRICT 3546 Concours Street Ontario, California 91764

INA ARBUCKLE ELEMENTARY SCHOOL 3600 Packard Street Jurupa Valley, CA 92509

EMG | A Bureau Veritas Company 10461 Mill Run Circle, Suite 1100 Owings Mills, Maryland 21117 800.733.0660 www.emgcorp.com

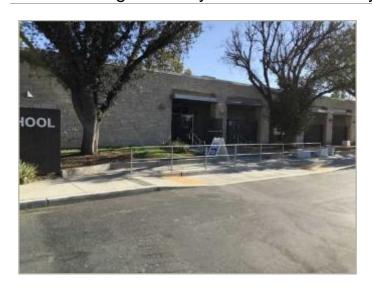
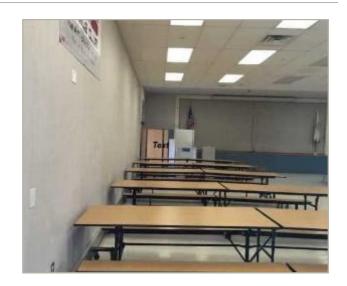
1. Building A-B Systems Summary

0000 Parkered Otracet, Islanda Nalland OA 00500	
Address	3600 Packard Street, Jurupa Valley, CA 92509	
Constructed/Renovated	1956/ 2018	
Building Size	8,504 SF	
Number of Stories	1	
System	Description	Condition
Structure	Conventional wood and steel frame structure on concrete slab with concrete-topped metal decks	Good
Façade	Stucco with aluminum windows Dry stacked stone	Good
Roof	Primary: Gable construction with built-up finish	Good
Interiors	Walls: Painted gypsum board & CMU, painted Floors: Carpet, VCT & ceramic tile Ceilings: Suspended ACT	Good
Elevators	None	Good
Plumbing	Copper supply and cast iron waste & venting Electric domestic water heaters. Toilets, urinals, and sinks in all restrooms	Good

Building A-B: Systems Summary			
HVAC	Individual package	Good	
Fire Suppression	None		
Electrical	Source & Distribution: Main panel Fed from A building with copper wiring Interior Lighting: T-8, T-12, CFL	Good	
Fire Alarm	Alarm panel, smoke detectors, alarms, strobes, pull stations, back-up emergency lights, and exit signs	Good	
Equipment/Special	None		
Accessibility	No Issues		
Key Issues and Findings	No Issues

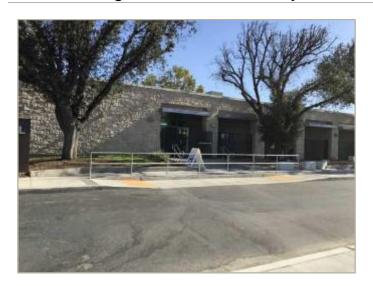
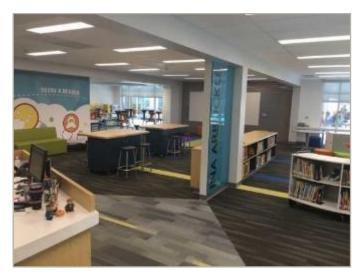
2. Building C,D,E,F & G Systems Summary

Building C, D, E, F &	G: Systems Summary	
Address	3600 Packard Street, Jurupa Valley, CA 92509	
Constructed/Renovated	1956/ 2018	
Building Size	C: 4,180 SF	
	D: 3,790 SF	
	E: 3,790 SF	
	F: 3,790 SF	
	G: 3,790 SF	
Number of Stories	1	
System	Description	Condition
Structure	Conventional wood and steel frame structure on concrete slab with concrete-topped metal decks	Good
Façade	Stucco with aluminum windows	Good
,	Dry stacked stone	
Roof	Primary: Gable construction with built-up finish	Good
Interiors	Walls: Painted gypsum board & CMU, painted	Good
	Floors: Carpet, VCT & ceramic tile	2234
	Ceilings: Suspended ACT	
Elevators	None	Good

Building C, D, E, F &	G: Systems Summary	
Plumbing	Copper supply and cast iron waste & venting Electric domestic water heaters. Toilets, urinals, and sinks in all restrooms	
HVAC	Individual package	Good
Fire Suppression	None	
Electrical	Source & Distribution: Main panel Fed from A building with copper wiring Interior Lighting: T-8, T-12, CFL	Good
Fire Alarm	Alarm panel, smoke detectors, alarms, strobes, pull stations, back-up emergency lights, and exit signs	Good
Equipment/Special	None	
Accessibility	No Issues	
Key Issues and Findings	No Issues

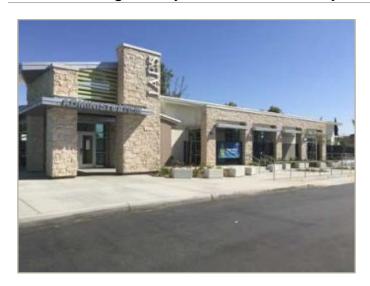
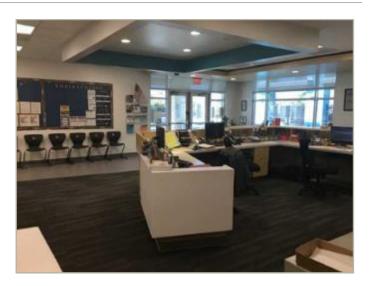
3. Building H Sytems Summary

Building H: Systems	S Summary	
Address	3600 Packard Street, Jurupa Valley, CA 92509	
Constructed/Renovated	2018	
Building Size	9,000 SF	
Number of Stories	1	
System	Description	Condition
Structure	Conventional wood and steel frame structure on concrete slab with concrete-topped metal decks	Good
Façade	Stucco with aluminum windows Dry stacked stone	Good
Roof	Primary: Gable construction with built-up finish	Good
Interiors	Walls: Painted gypsum board & CMU, painted Floors: Carpet, VCT & ceramic tile Ceilings: Suspended ACT	Good
Elevators	None	Good
Plumbing	Copper supply and cast iron waste & venting Electric domestic water heaters. Toilets, urinals, and sinks in all restrooms	Good

Building H: Systems Summary			
HVAC	Individual package	Good	
Fire Suppression	None		
Electrical	Source & Distribution: Main panel Fed from A building with copper wiring Interior Lighting: T-8, T-12, CFL	Good	
Fire Alarm	Alarm panel, smoke detectors, alarms, strobes, pull stations, back-up emergency lights, and exit signs	Good	
Equipment/Special	None		
Accessibility	No Issues		
Key Issues and Findings	No Issues

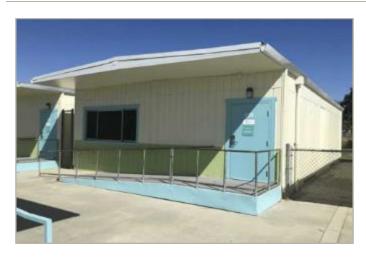
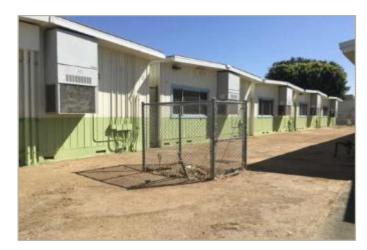
4. Portable Classrooms Systems Summary

Portable Classroom	s: Systems Summary	
Address	8700 Galena Street, Jurupa Valley, CA 92509	
Constructed/Renovated	1975/ 2018	
Building Size	P21-P33: 882 SF P34-P36: 1,253 SF P37-P41: 882 SF	
Number of Stories	1	
System	Description	Condition
Structure	Conventional wood frame structure with raised floor	Fair
Façade	Wood siding with aluminum windows	Fair
Roof	Primary: Flat construction with coated metal finish	Fair
Interiors	Walls: vinyl , painted Floors: Carpet Ceilings: ACT	Fair
Elevators	None	Fair
Plumbing	Copper supply and cast iron waste & venting Toilets, urinals, and sinks in all restrooms	Fair

Portable Classrooms: Systems Summary			
HVAC	Individual package through wall	Fair	
Fire Suppression	None		
Electrical	Source & Distribution: Main panel fed from site with copper wiring Interior Lighting: T-8, T-12	Fair	
Fire Alarm	Alarm panel, smoke detectors, alarms, strobes, pull stations, back-up emergency lights, and exit signs	Fair	
Equipment/Special	None		
Accessibility	Presently it does not appear an accessibility study is needed for this building.		
Key Issues and Findings	Some of the HVAC units appear to be close to end of life expectancy. The nameplate da not visible.	ata was

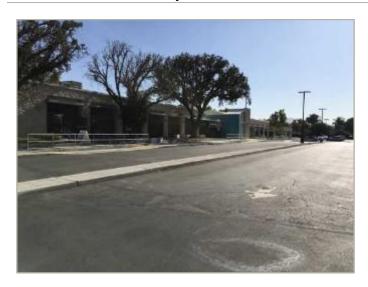
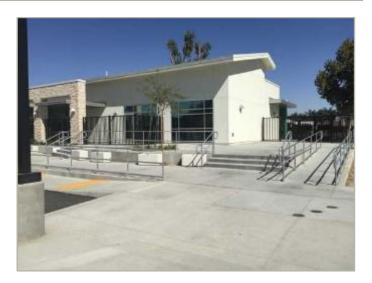
5. Site Summary

Site Information		
Lot Size	8.30 acres (estimated)	
Parking Spaces	59 total; 2 accessible (included in total above)	
System	Description	Condition
Pavement/Flatwork	Asphalt lots with areas of concrete and concrete sidewalks, curbs, ramps, and stairs	Good
Site Development	Building-mounted signage, chain link temporary fencing, iron tube fencing, CMU dumpster enclosures	Good
Site Development	Playgrounds and sports courts, and site lights Limited park benches, picnic tables, trash receptacles	
Landscaping and Topography	No significant landscaping features Irrigation not present No retaining walls Low to moderate site slopes throughout	Good
Utilities	Municipal water and sewer Local utility-provided electric and natural gas	Good
Site Lighting	Pole-mounted: LED	Good
Ancillary Structures	Playground equipment	Fair
Key Issues and Findings	Heavy asphalt wear, severe alligator cracking and potholes in asphalt walk ways and sport court areas
