# FACILITY CONDITION ASSESSMENT

**TROTH STREET ELEMENTARY SCHOOL**  
5565 Troth Street  
Jurupa Valley, California 91752

139069.19R000-001.354

August 28, 2019

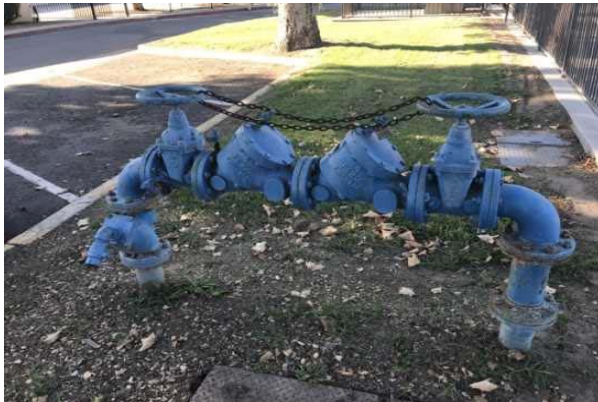
#27	BACKFLOW PREVENTER
-----	--------------------
