FACILITY CONDITION ASSESSMENT

October 30, 2019

PEDLEY ELEMENTARY SCHOOL
5871 Hudson Street
Jurupa Valley, California 92509

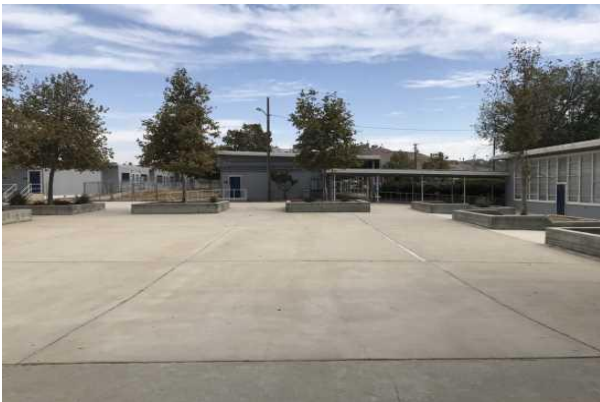
#11	SCHOOL INNER COURT
-----	--------------------
