FACILITY CONDITION ASSESSMENT

October 22, 2019

PERALTA ELEMENTARY SCHOOL

6450 Peralta Place
Jurupa Valley, California 92509

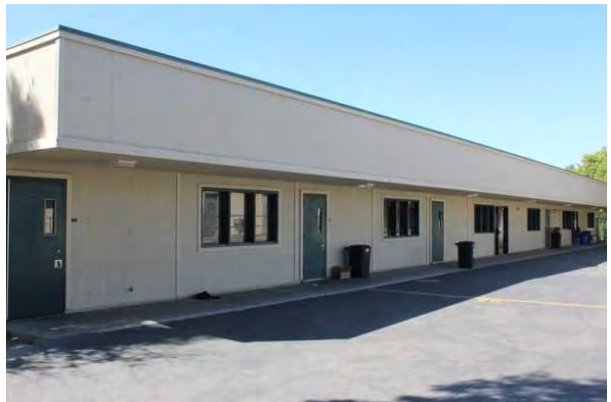
#12	WINDOW, ALUMINUM DOUBLE-GLAZED
-----	--------------------------------

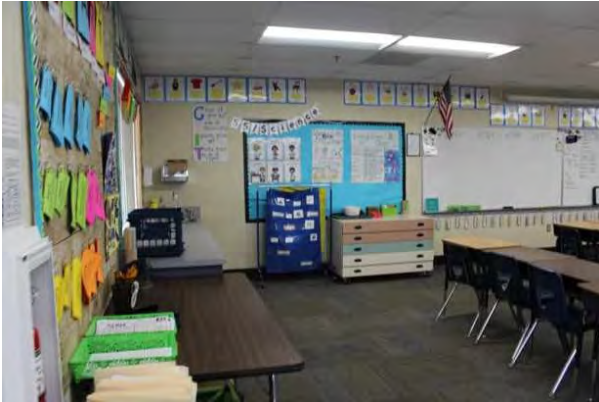
#19 INTERIOR FLOOR FINISH, CARPET COMMERCIAL TILE

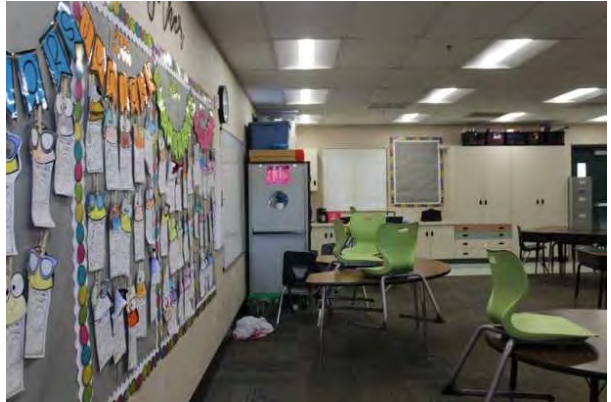
#20 INTERIOR FLOOR FINISH, CARPET COMMERCIAL TILE

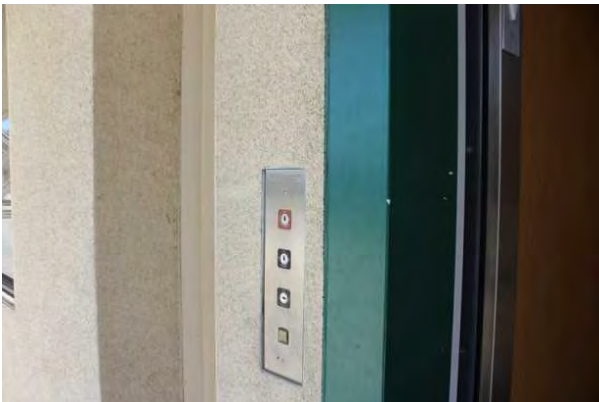
#23 ELEVATOR, HYDRAULIC

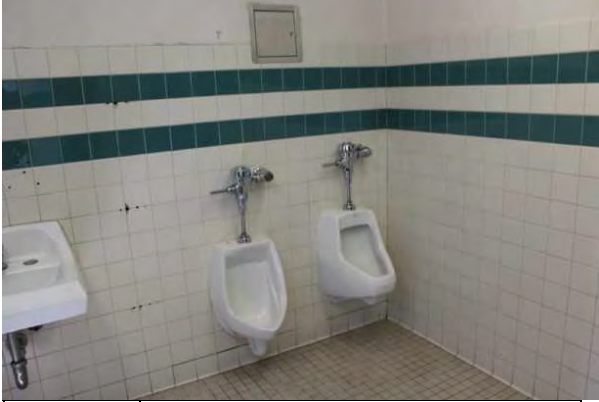
#24 TOILET, COMMERCIAL WATER CLOSET

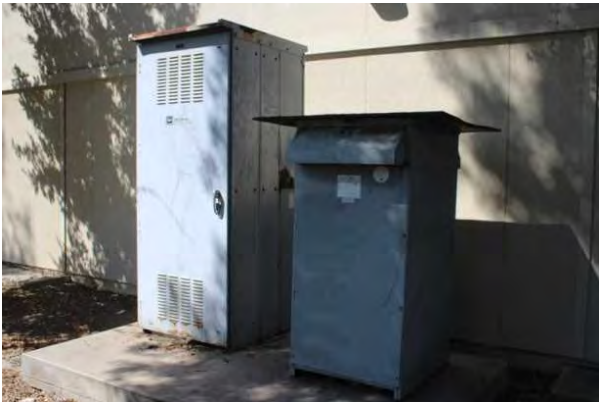
#38	SECONDARY TRANSFORMER
-----	-----------------------

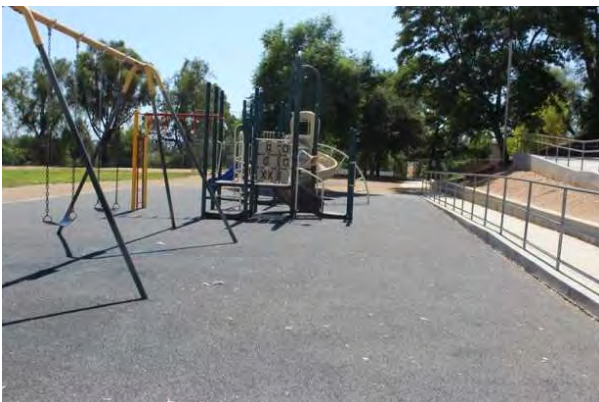
#52	PLAY STRUCTURE, MEDIUM
-----	------------------------

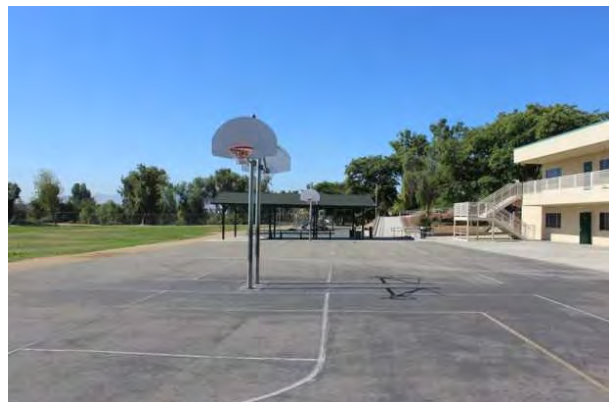
#53	PLAY SURFACES AND SPORTS COURTS, POURED-IN-PLACE RUBBER
-----	---
