FACILITY CONDITION ASSESSMENT

January 14, 2020

WEST RIVERSIDE ELEMENTARY SCHOOL
3972 Riverview Drive
Jurupa Valley, California 92509

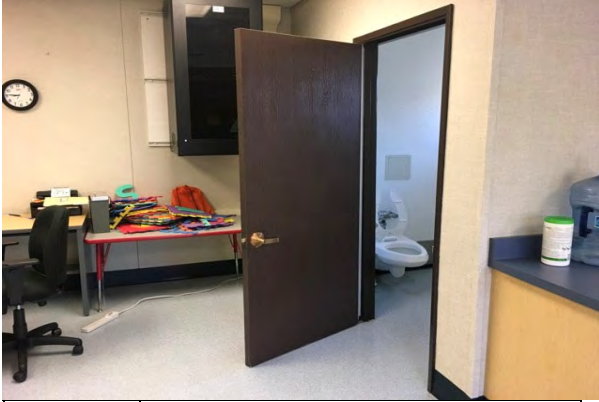
#30 INTERIOR WALL FINISH

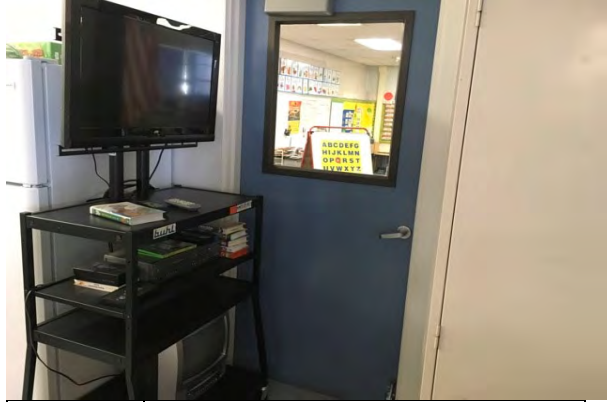
#31	INTERIOR DOOR, WOOD SOLID-CORE
-----	--------------------------------

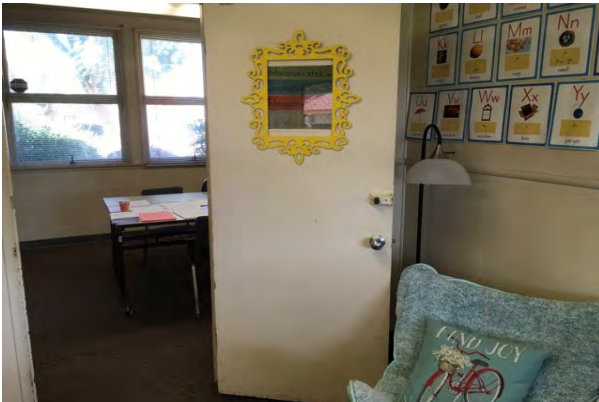
#32	INTERIOR DOOR, WOOD SOLID-CORE WITH GLASS
-----	---

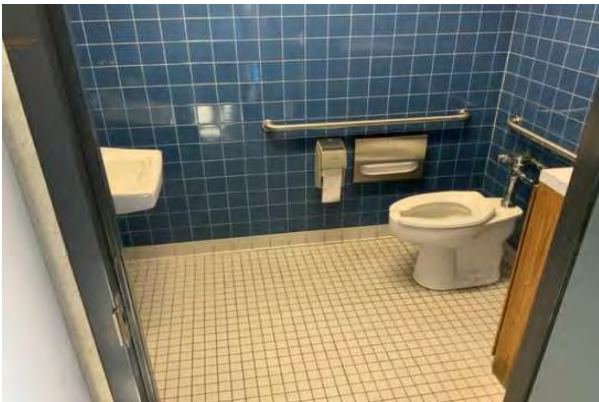
#34	INTERIOR FLOOR FINISH, CERAMIC TILE
-----	-------------------------------------

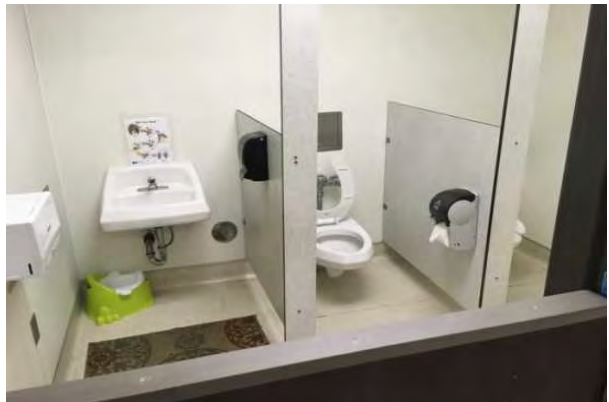
#35	RESTROOM
-----	----------

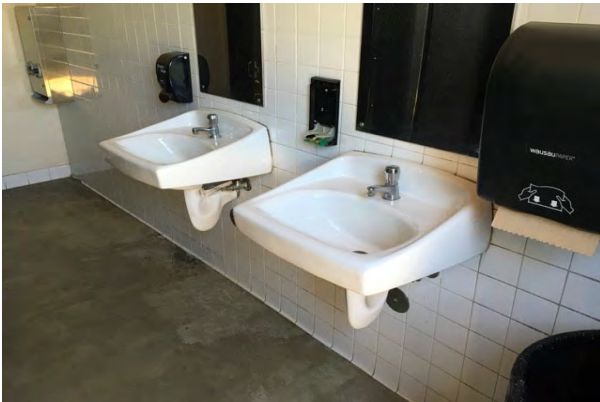
#36	RESTROOM
-----	----------

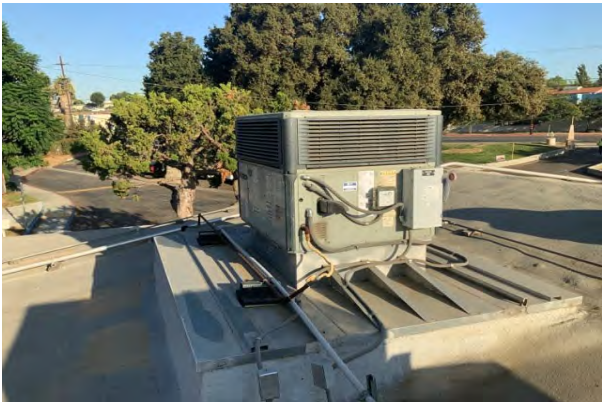
#44 PACKAGED UNIT (RTU)

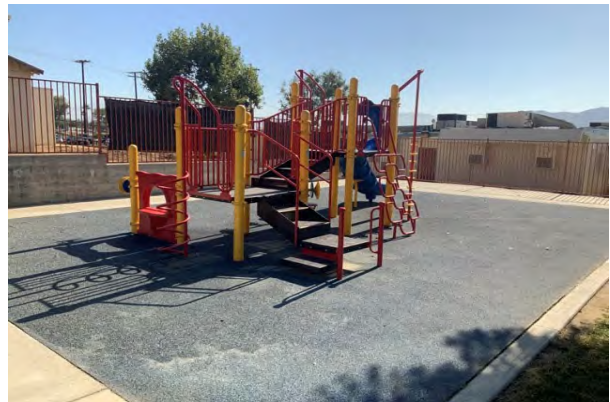
#53	PLAY STRUCTURE
-----	----------------
