# FACILITY CONDITION ASSESSMENT

November 26, 2019

## JURUPA MIDDLE SCHOOL

8700 Galena Street  
Jurupa Valley, CA 92509

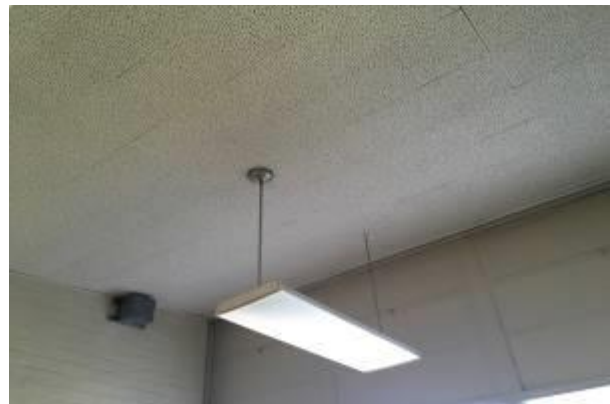
#47	INTERIOR WALL FINISH
-----	----------------------

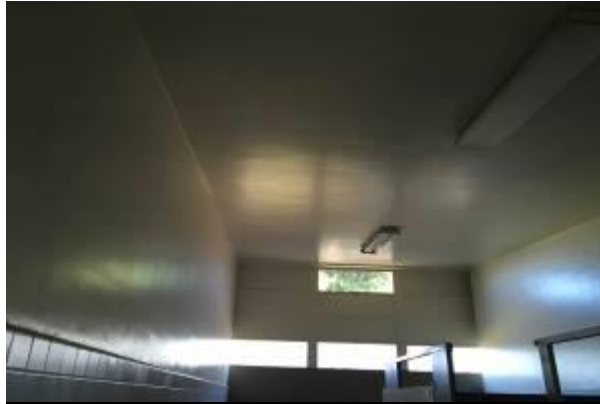
#48	INTERIOR LIGHTING
-----	-------------------

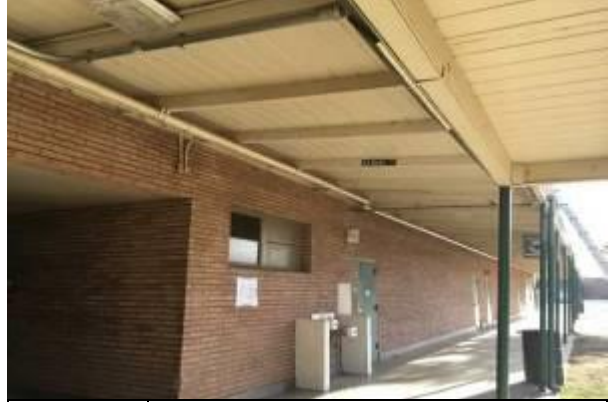
#55	STRUCTURAL OVERVIEW
-----	---------------------
